Appendix V

Report Date: November 03, 2021

Report Number: 178045

Re: Warning Letter, Unauthorized Discharge, Quinsam Coal Corporation, 5800 Argonaut Main, Campbell River, BC, Effluent

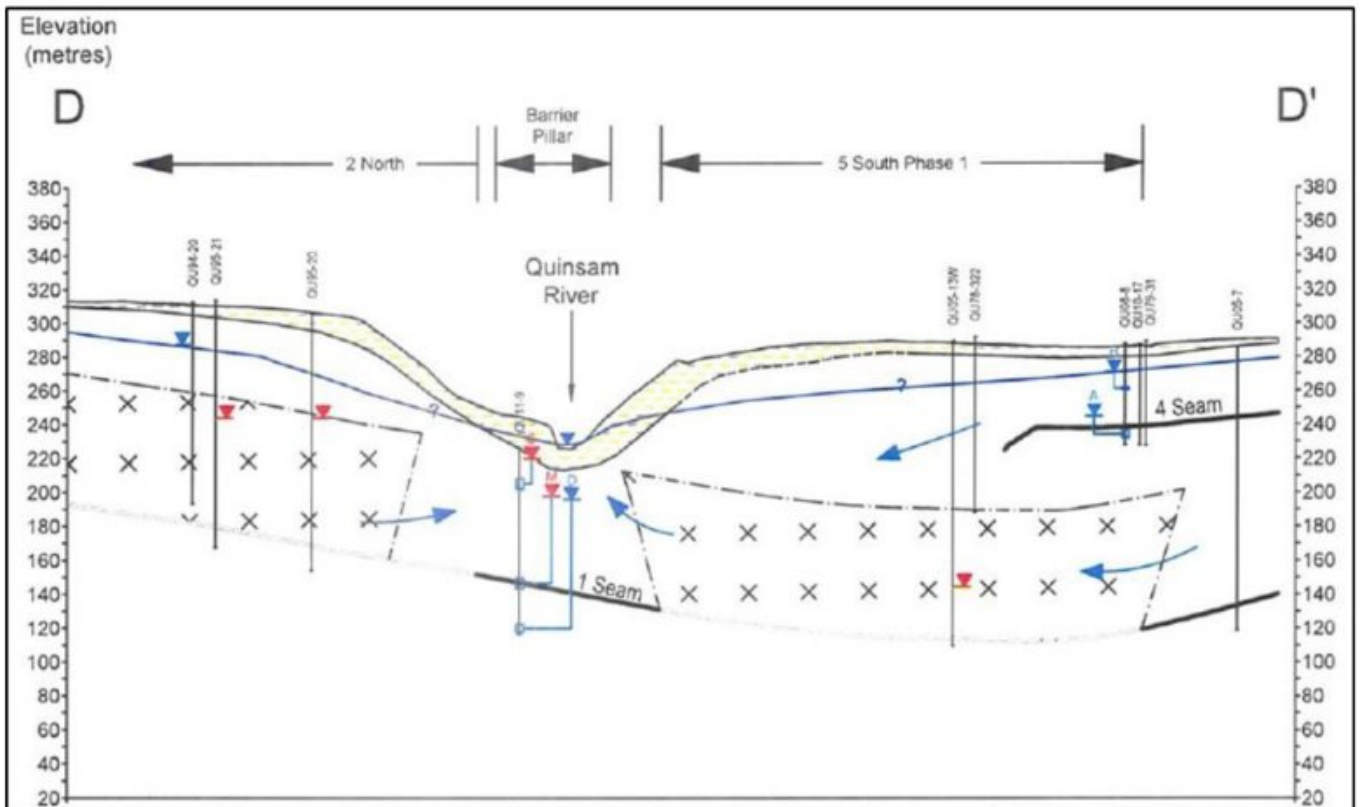
Img : 2021-10-13 Figure 1 - Source: Quinsam Follow-Up Report Unauthorized Discharge DGIR 204584 .jpg

Img comment: Figure 1. Cross section of 2-North Mine, River Barrier Pillar (QU11-09) and 5-South Mine provided by Quinsam in the DGIR 204584 Follow-Up Report.

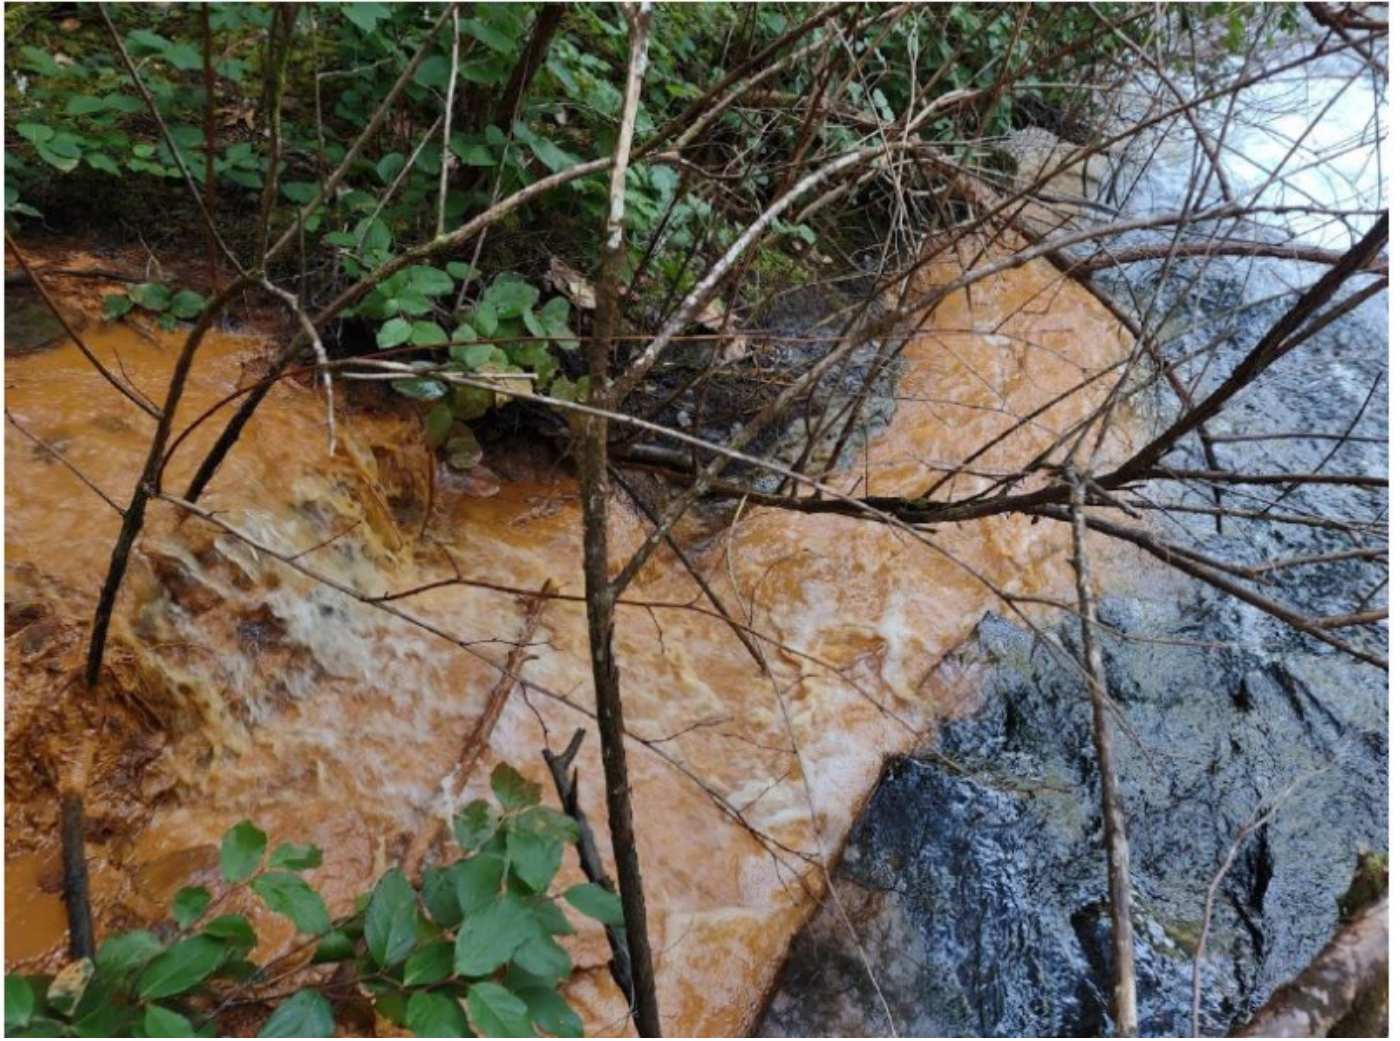
Img : 2021-10-13 Photo 7 from DGIR 204584 Follow-Up Report.jpg

Img comment: Photo 1 - Initial flow path of discharge into Quinsam River provided by Quinsam in the DGIR 204584 Follow-Up Report.

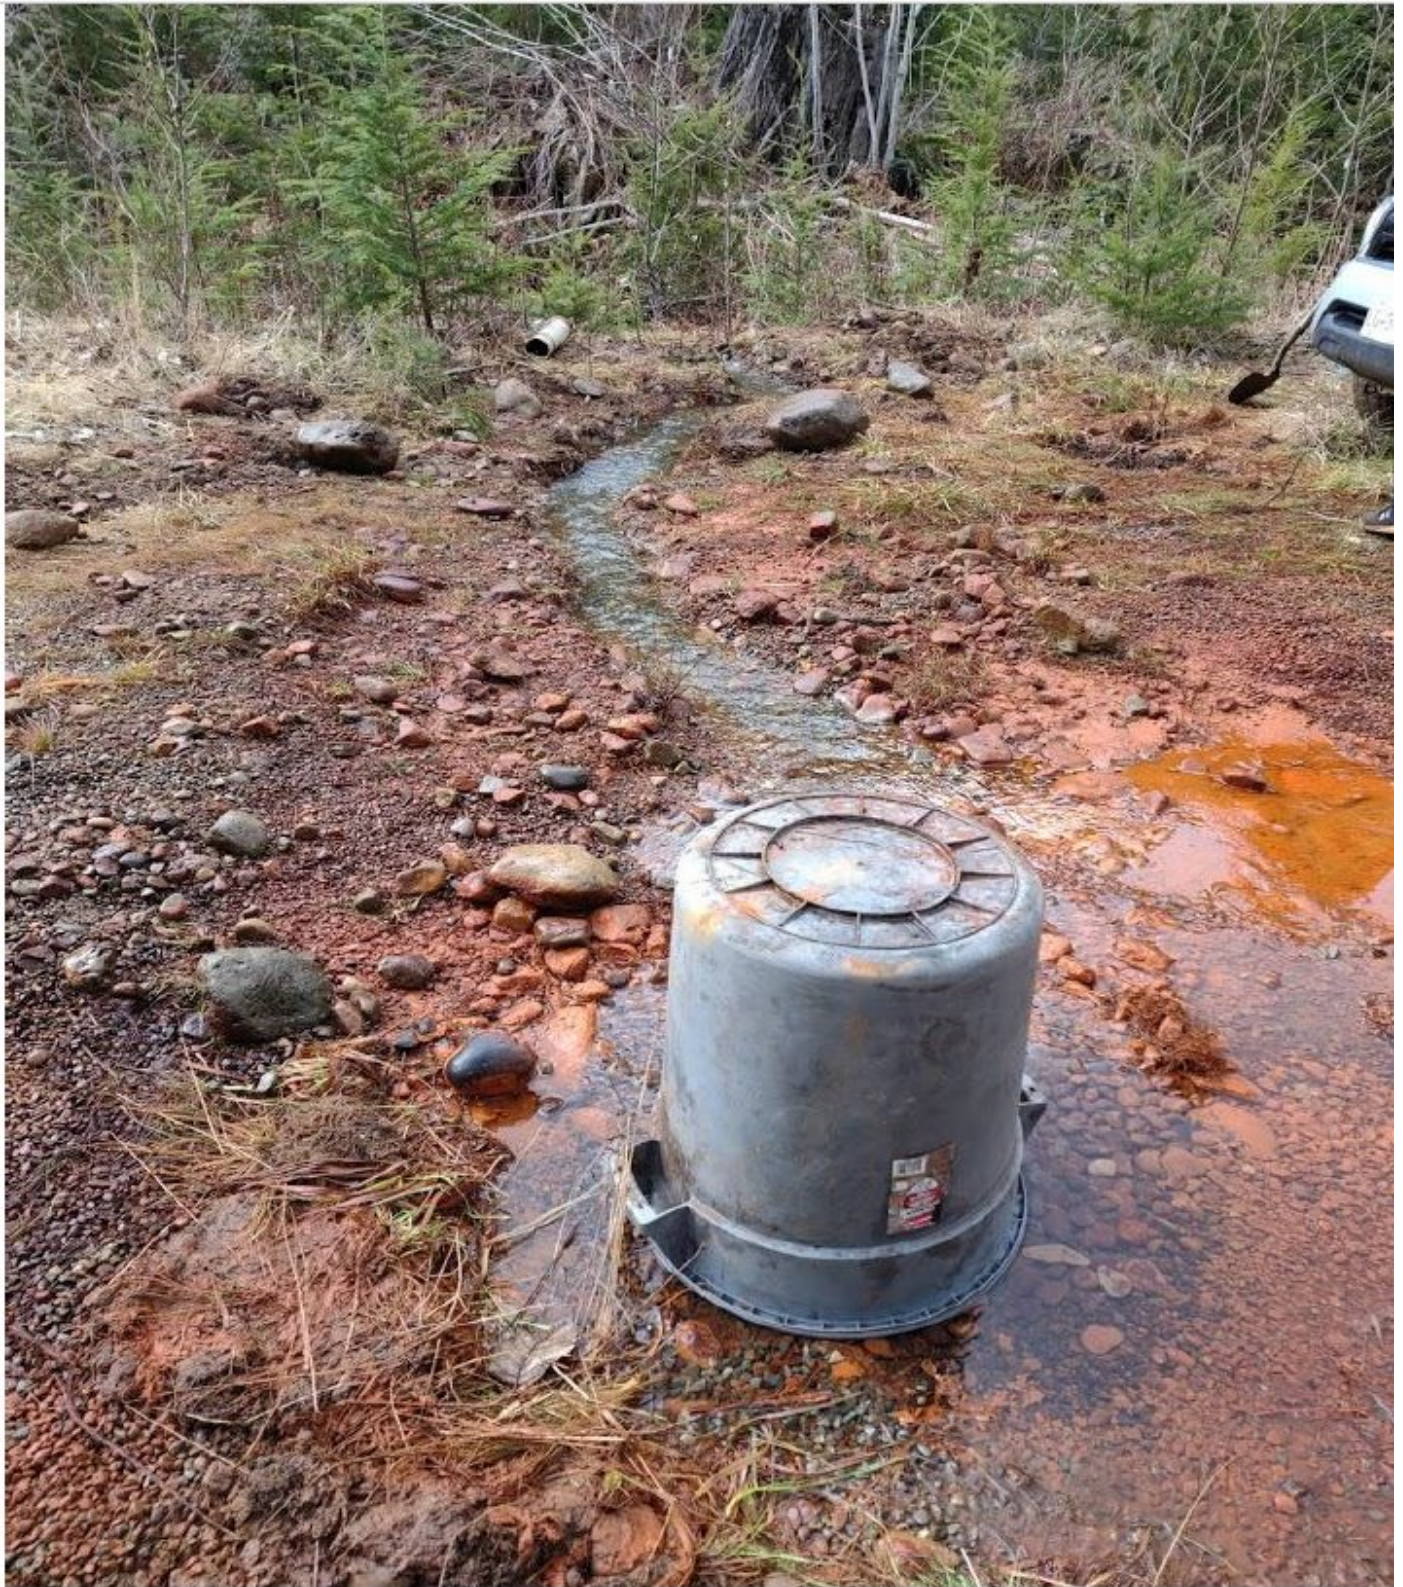
Img : 2021-10-13 Photo 3 from DGIR 204584 Follow-Up Report.jpg

Img comment: Photo 2 - Taken March 18, 2021, showing discharge contained and directed into a low-lying sump area next to the well away from the river. Photo provided by Quinsam in the DGIR 204584 Follow-Up Report.

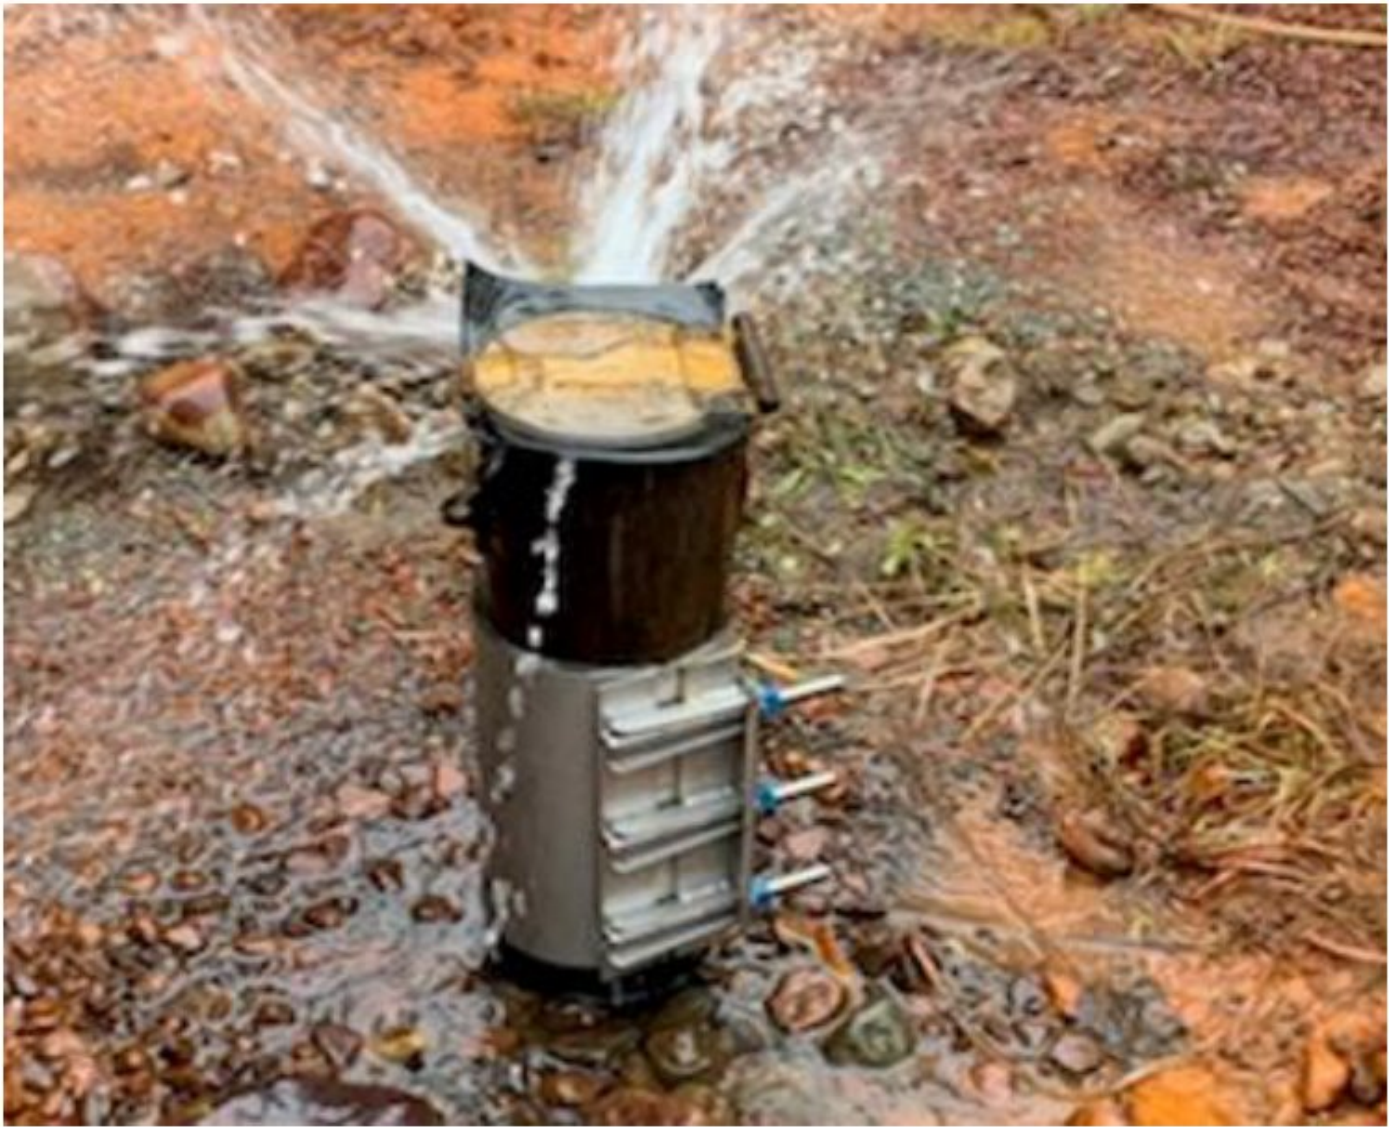
Img : 2021-10-13 Photo 4 from DGIR 204584 Follow-Up Report.jpg

Img comment: Photo 3 - Taken March 19, 2021 showing the well capped discharge still directed to the sump area. Photo provided by Quinsam in the DGIR 204584 Follow-Up Report.

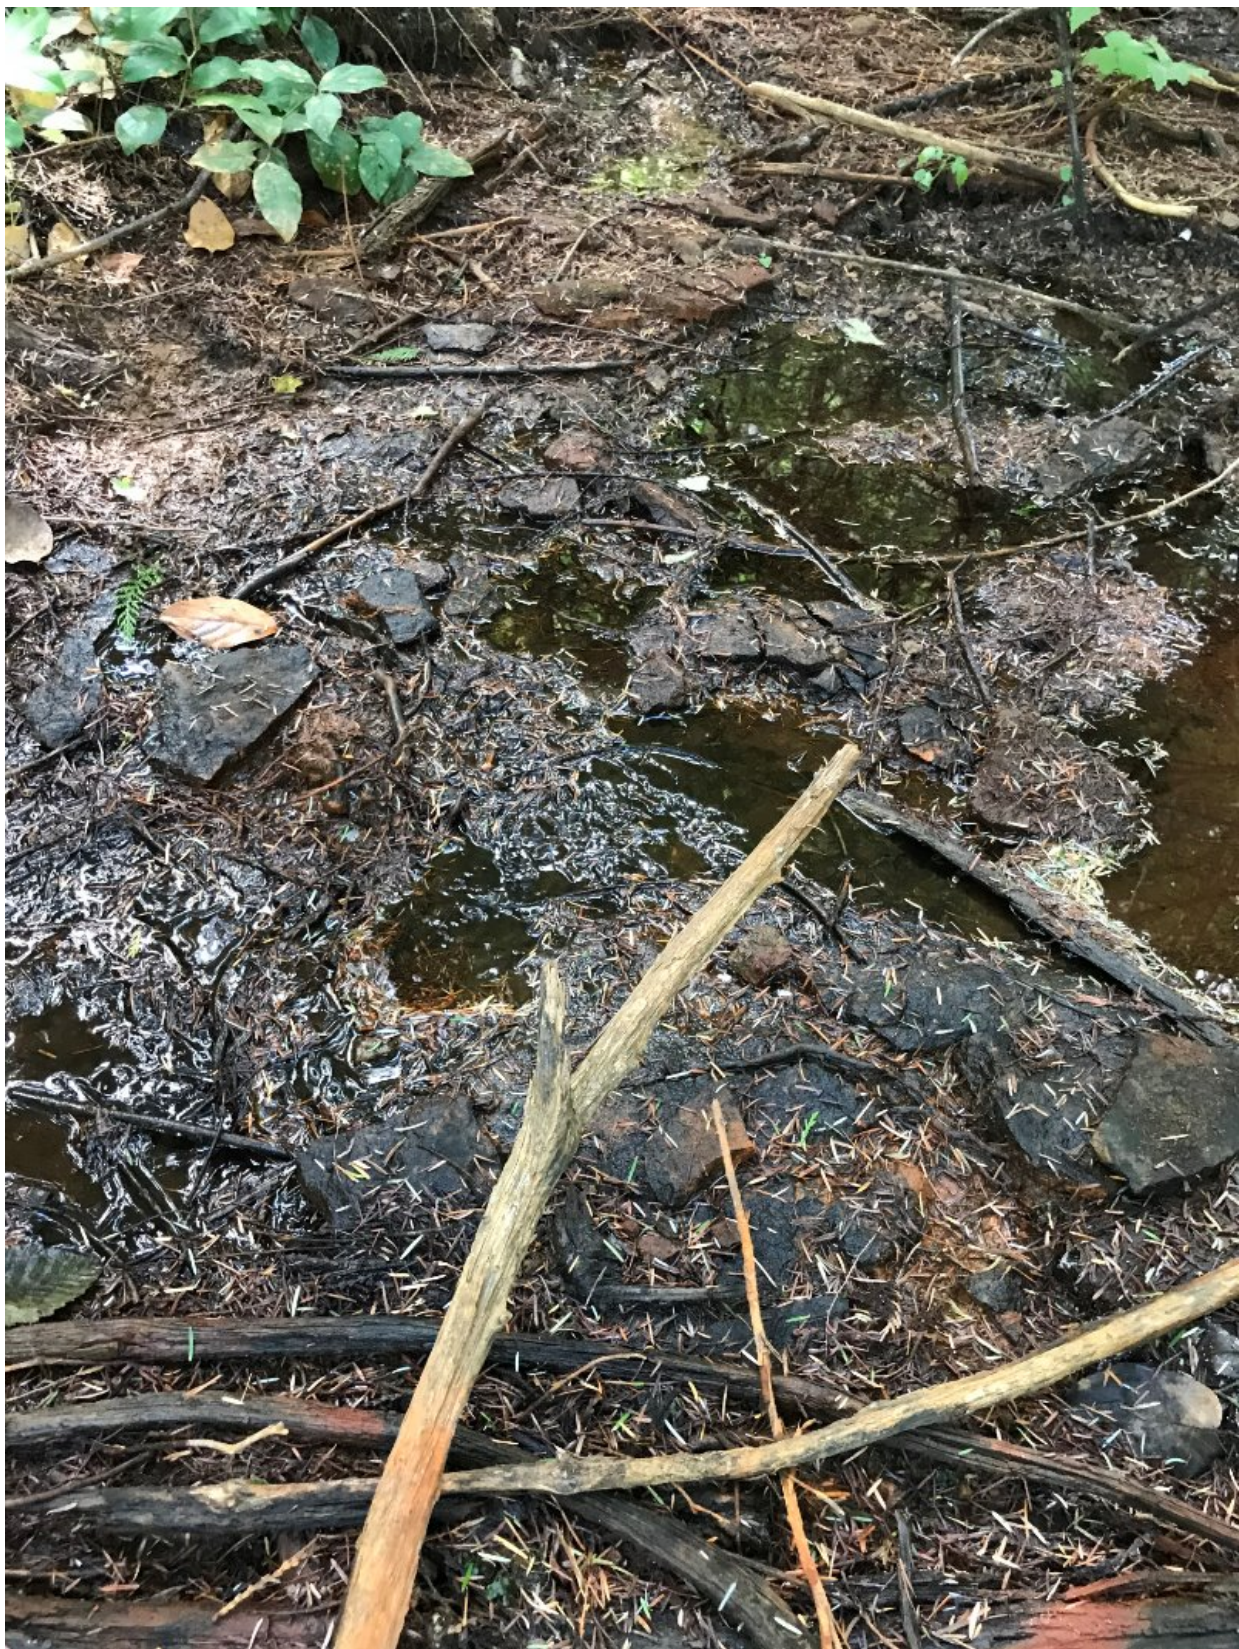
Img : Photo (28).jpg

Img comment: Photo 4 - puddles on the ground of the seep flow path near the Quinsam River.
Photo taken August 18, 2021, by Officer Dick.

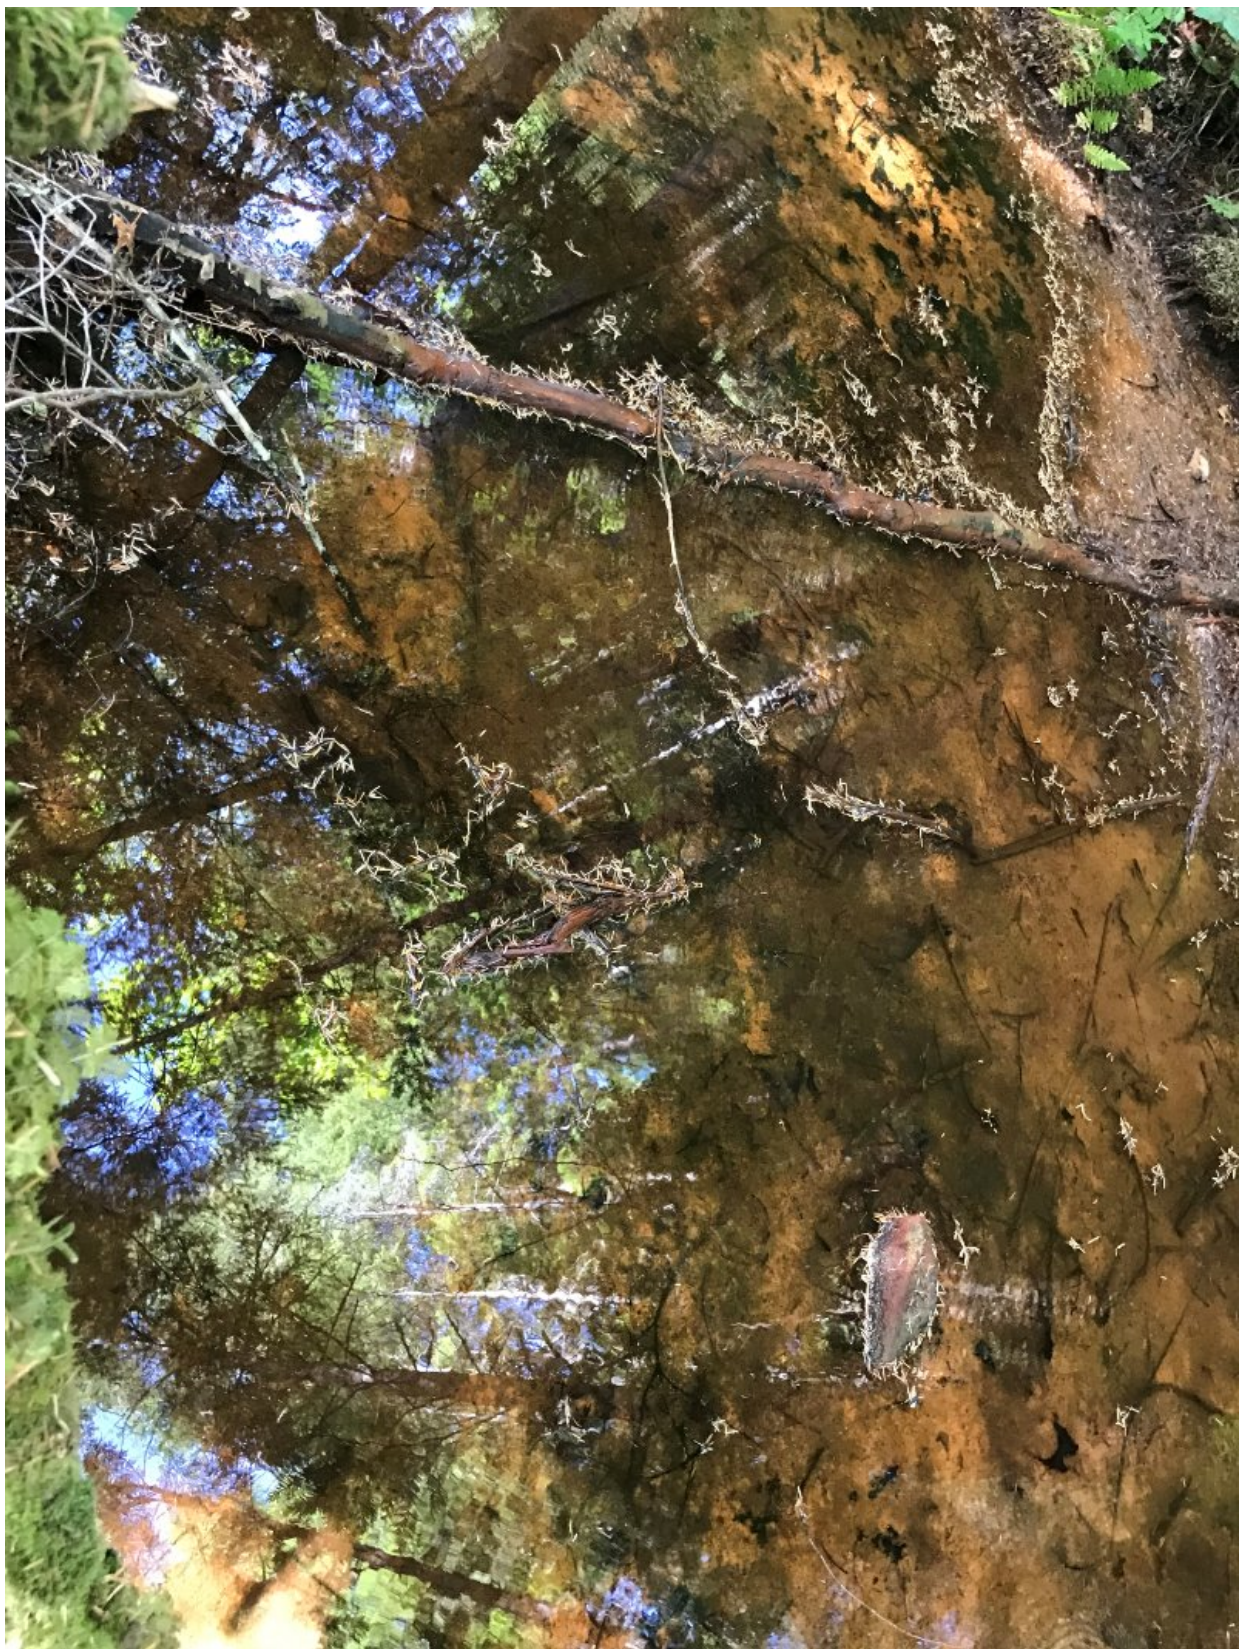
Img : Photo (30).jpg

Img comment: Photo 5 - puddle on the ground of the seep flow path farther back from the Quinsam River. Photo taken August 18, 2021, by Officer Dick.

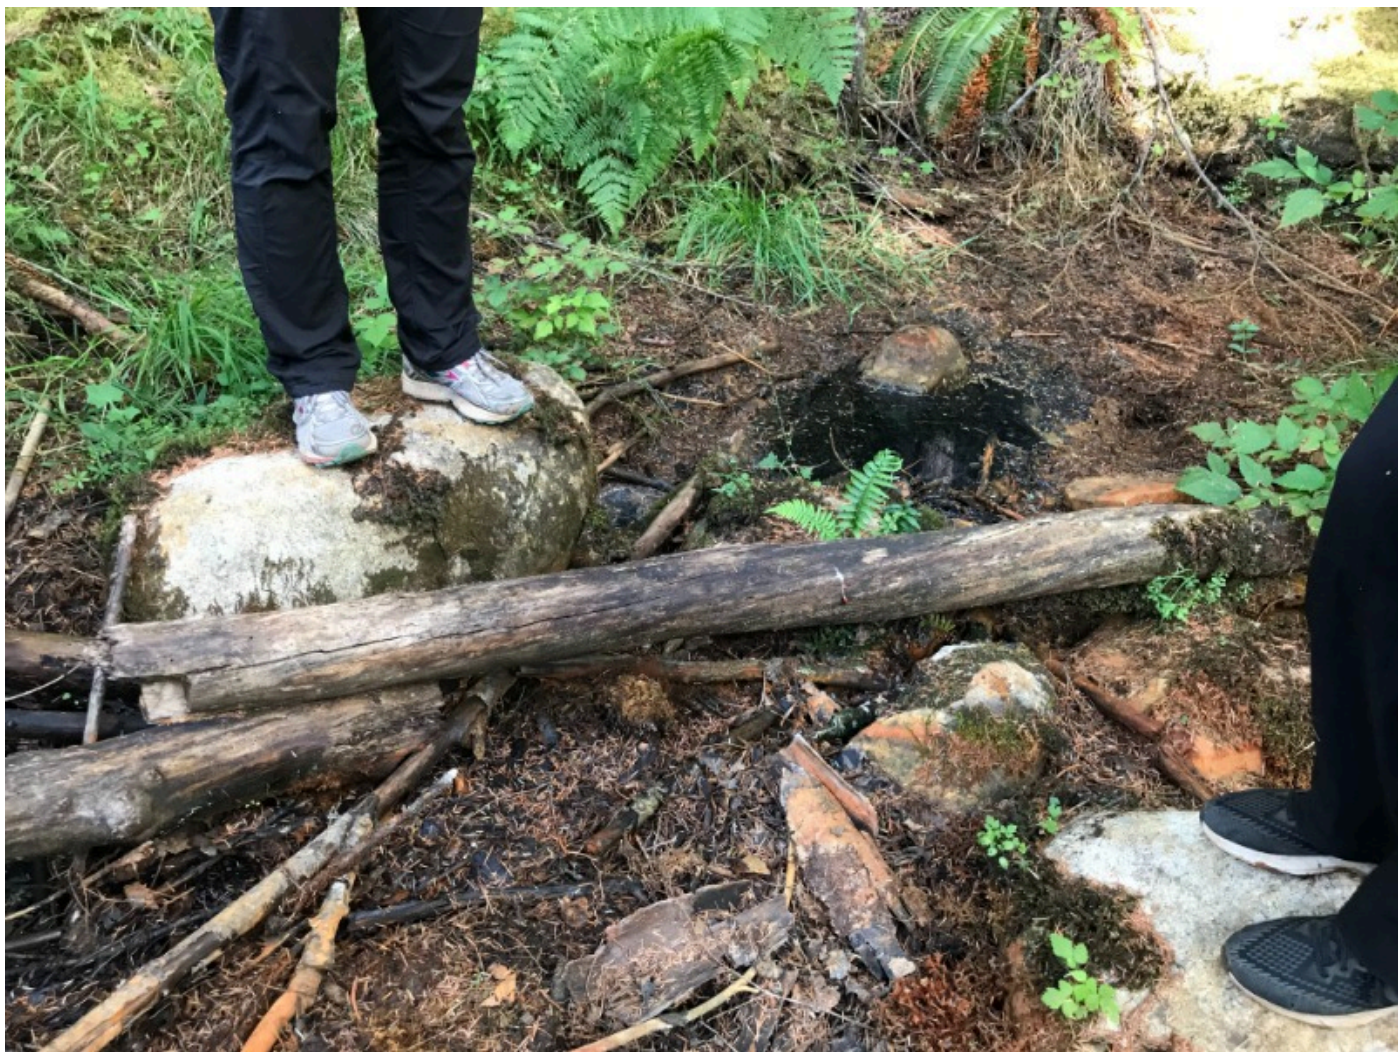
Img : Photo (25).jpg

Img comment: Photo 6 - Head of groundwater seep near QU11-09 which was flowing into the Quinsam River

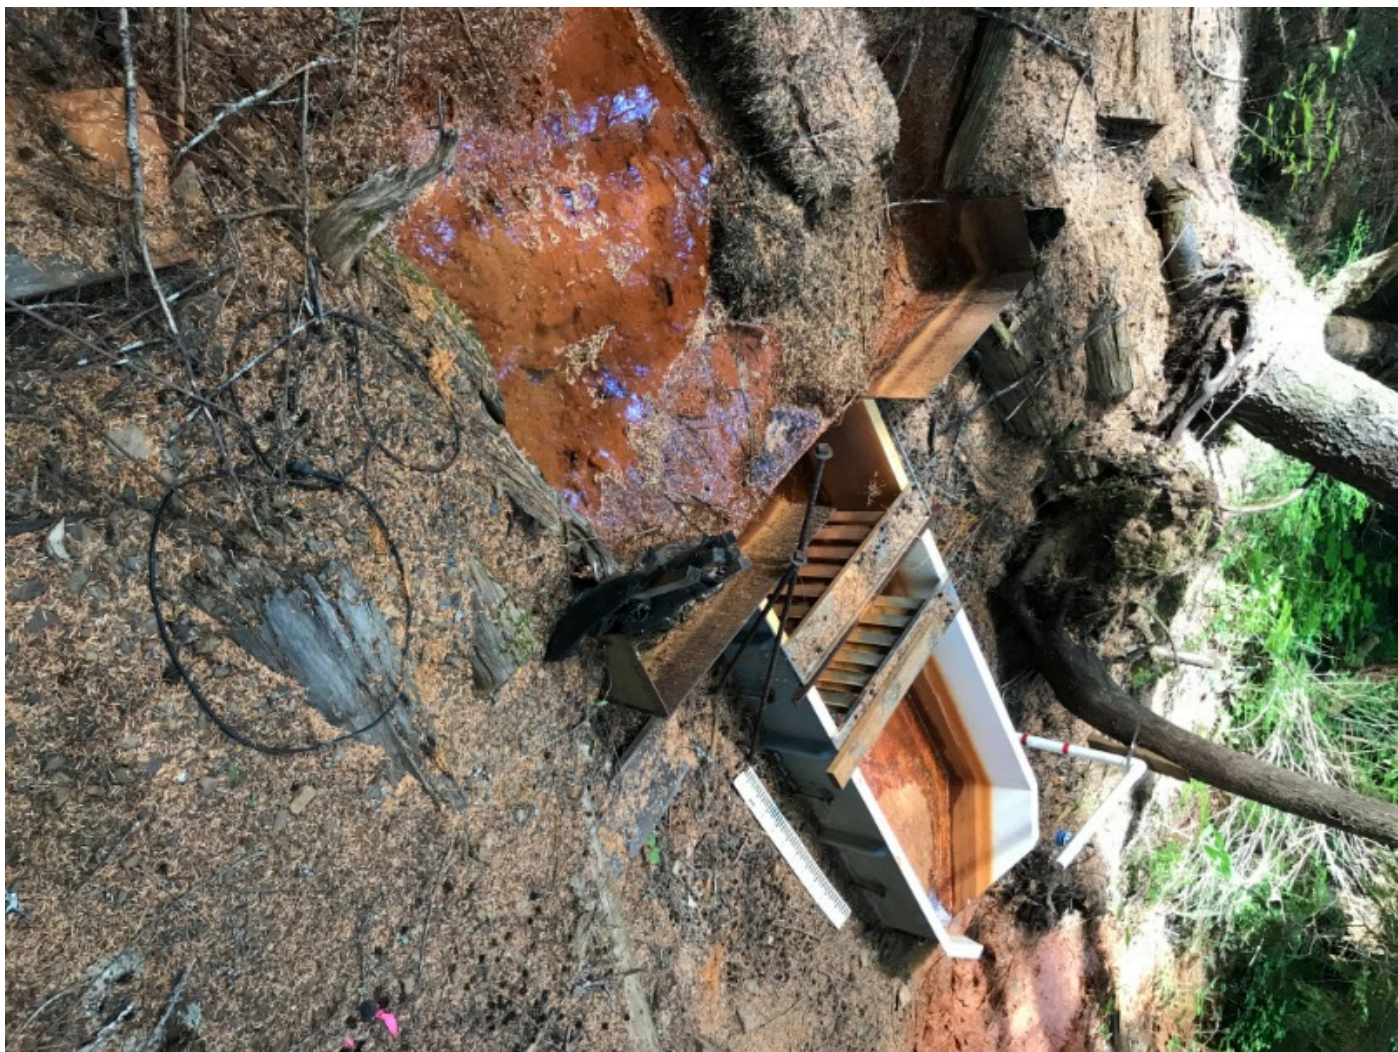
Img : Photo (60).jpg

Img comment: Photo 1 - LLSM Seep flow path taken from up gradient

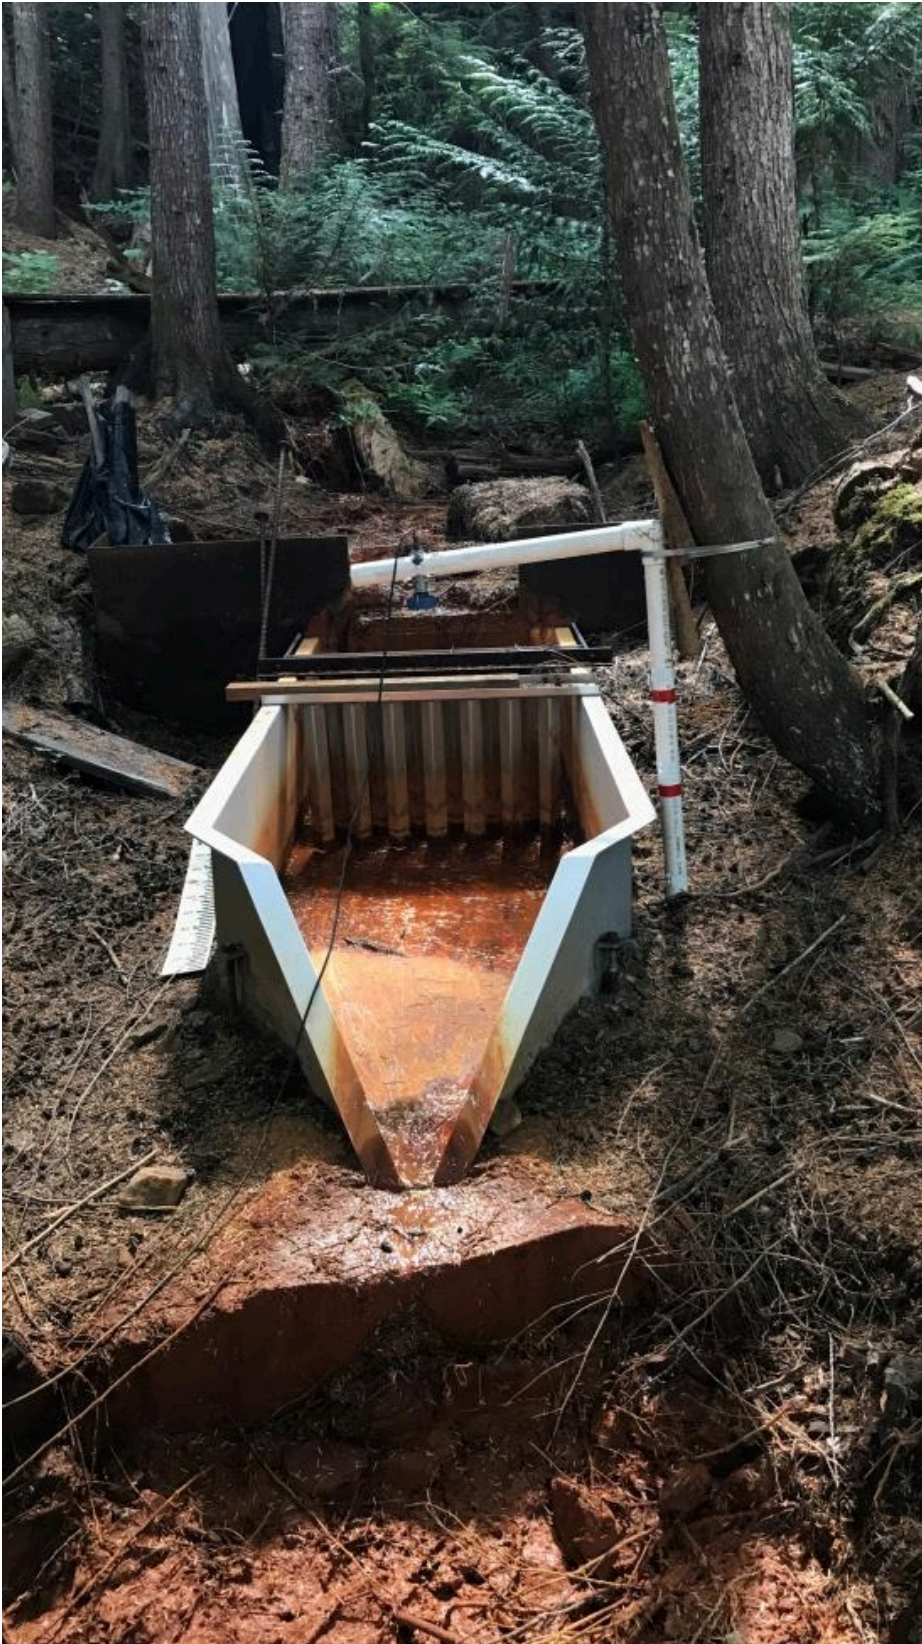
Img : 2021-08-19 Jason Photo (1).jpg

Img comment: Photo 2 - LLSM Seep flow path with mud and the flow appearing to end here

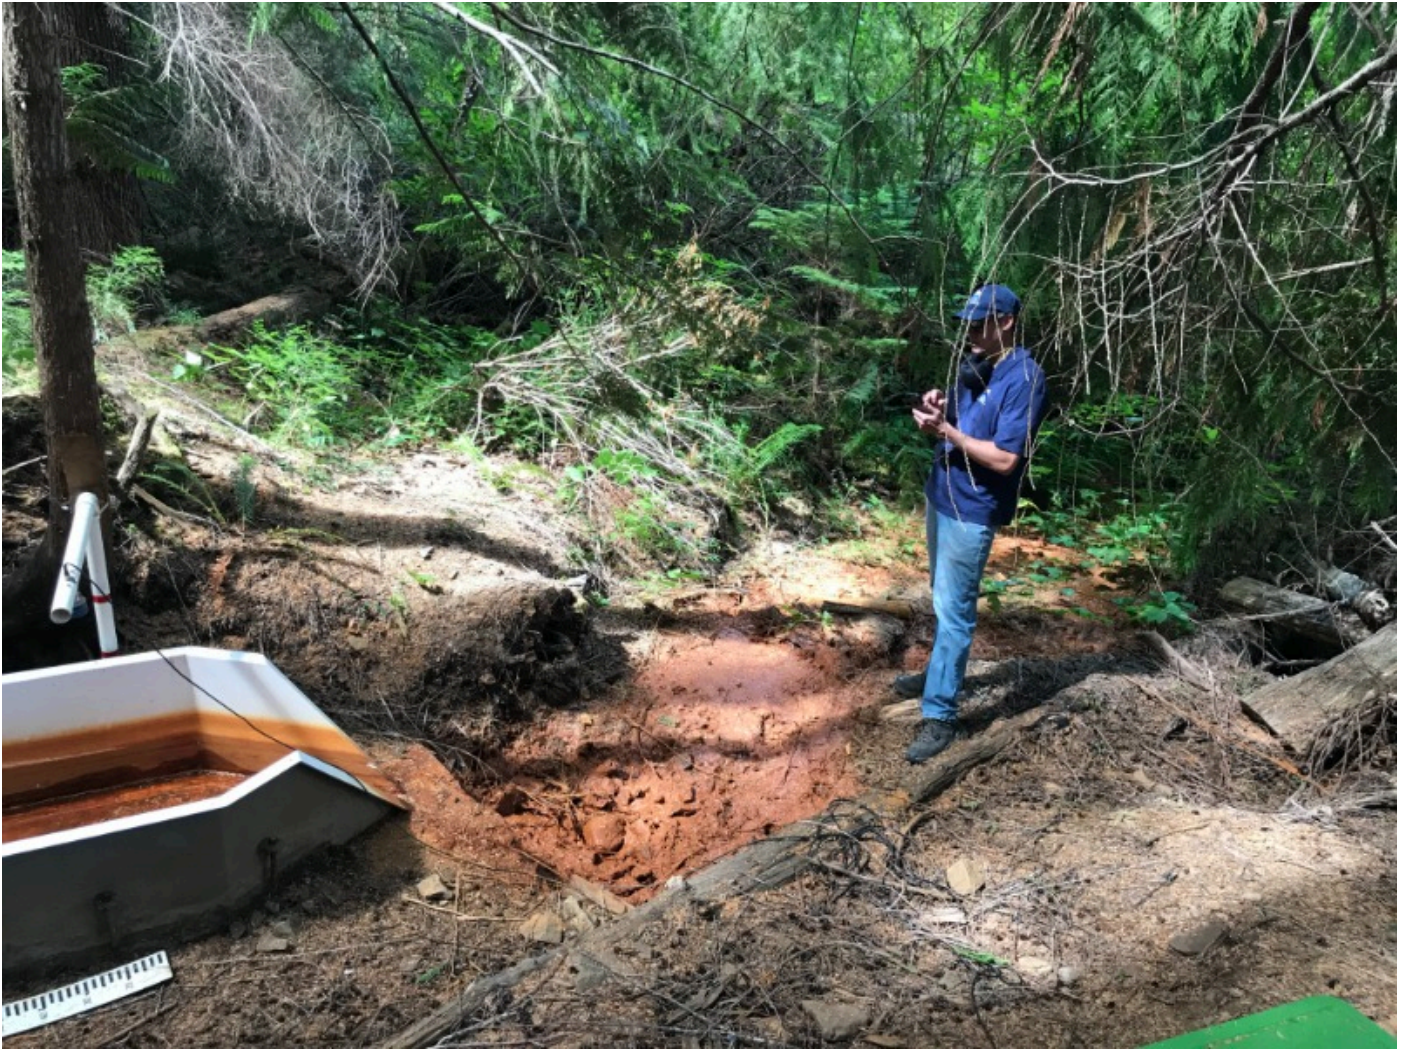
Img : Photo (66).jpg

Img comment: Photo 3 - LLSM Seep flow path with another view of the mud

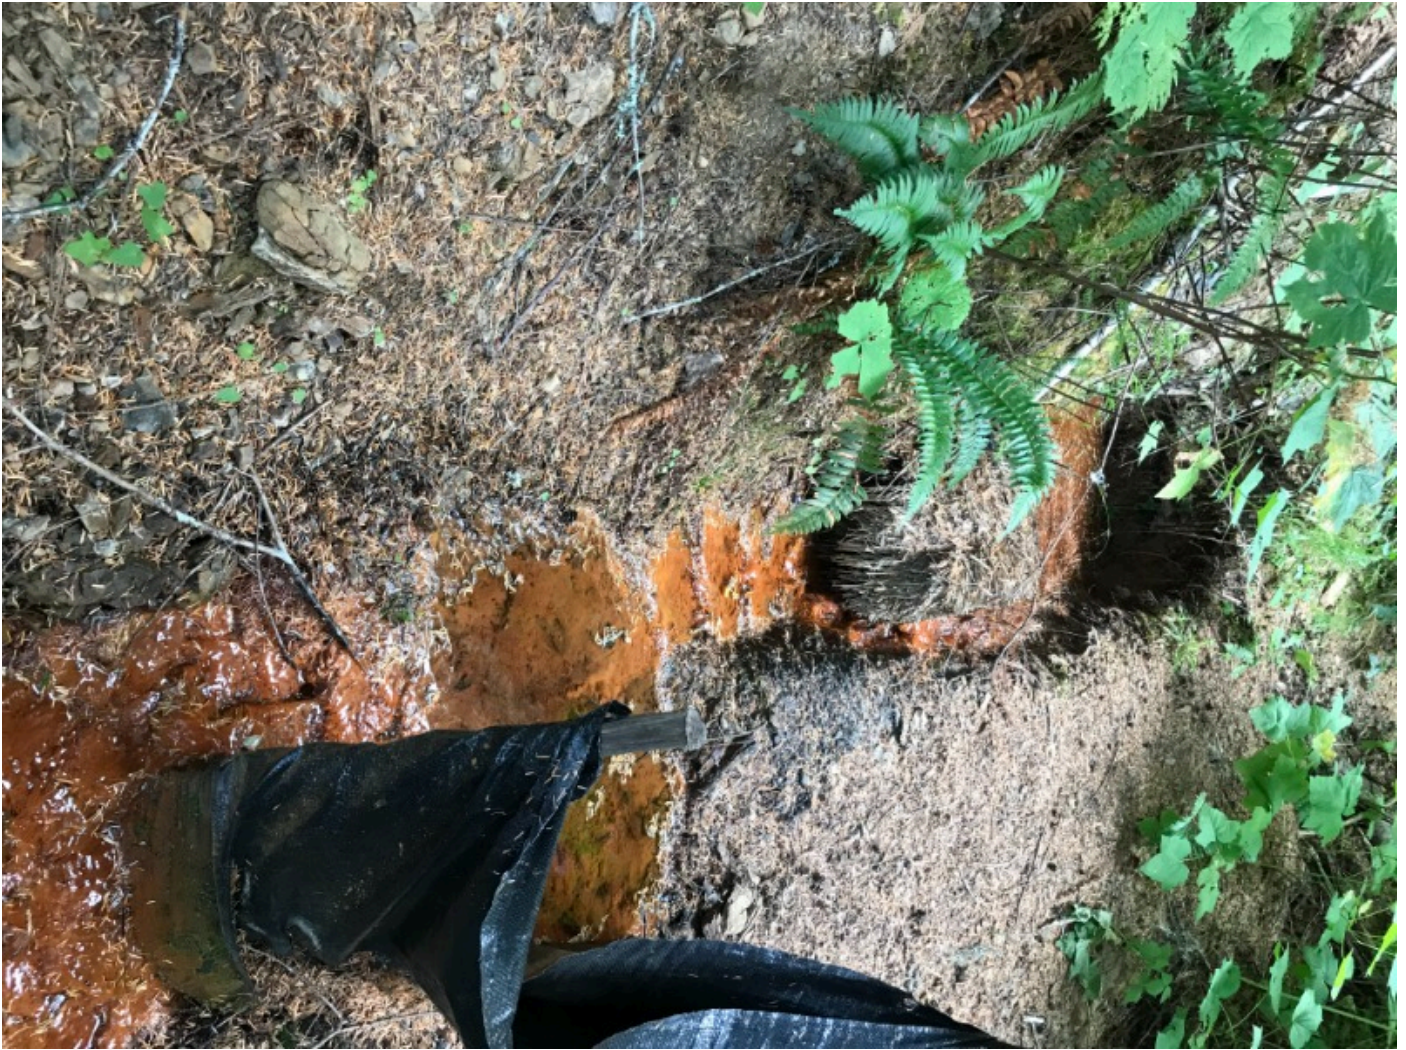
Img : Photo (70).jpg

Img comment: Photo 4 - LLS Seep flow path up gradient of weir

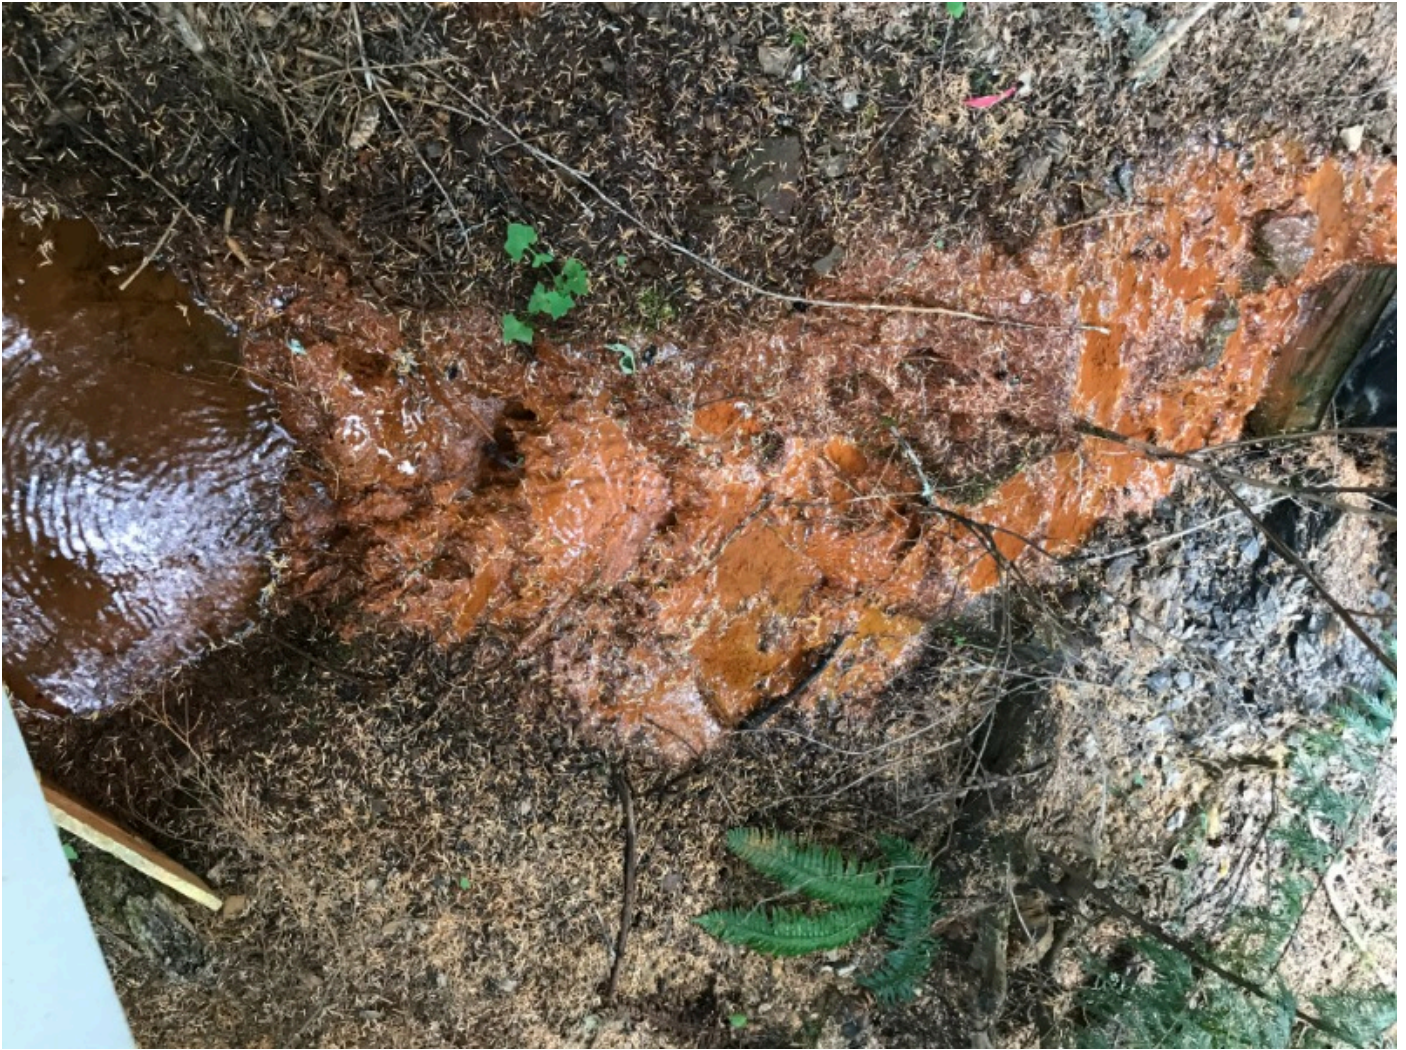
Img : Photo (69).jpg

Img comment: Photo 5 - LLS Seep flow path gradient of weir, but below Photo 4

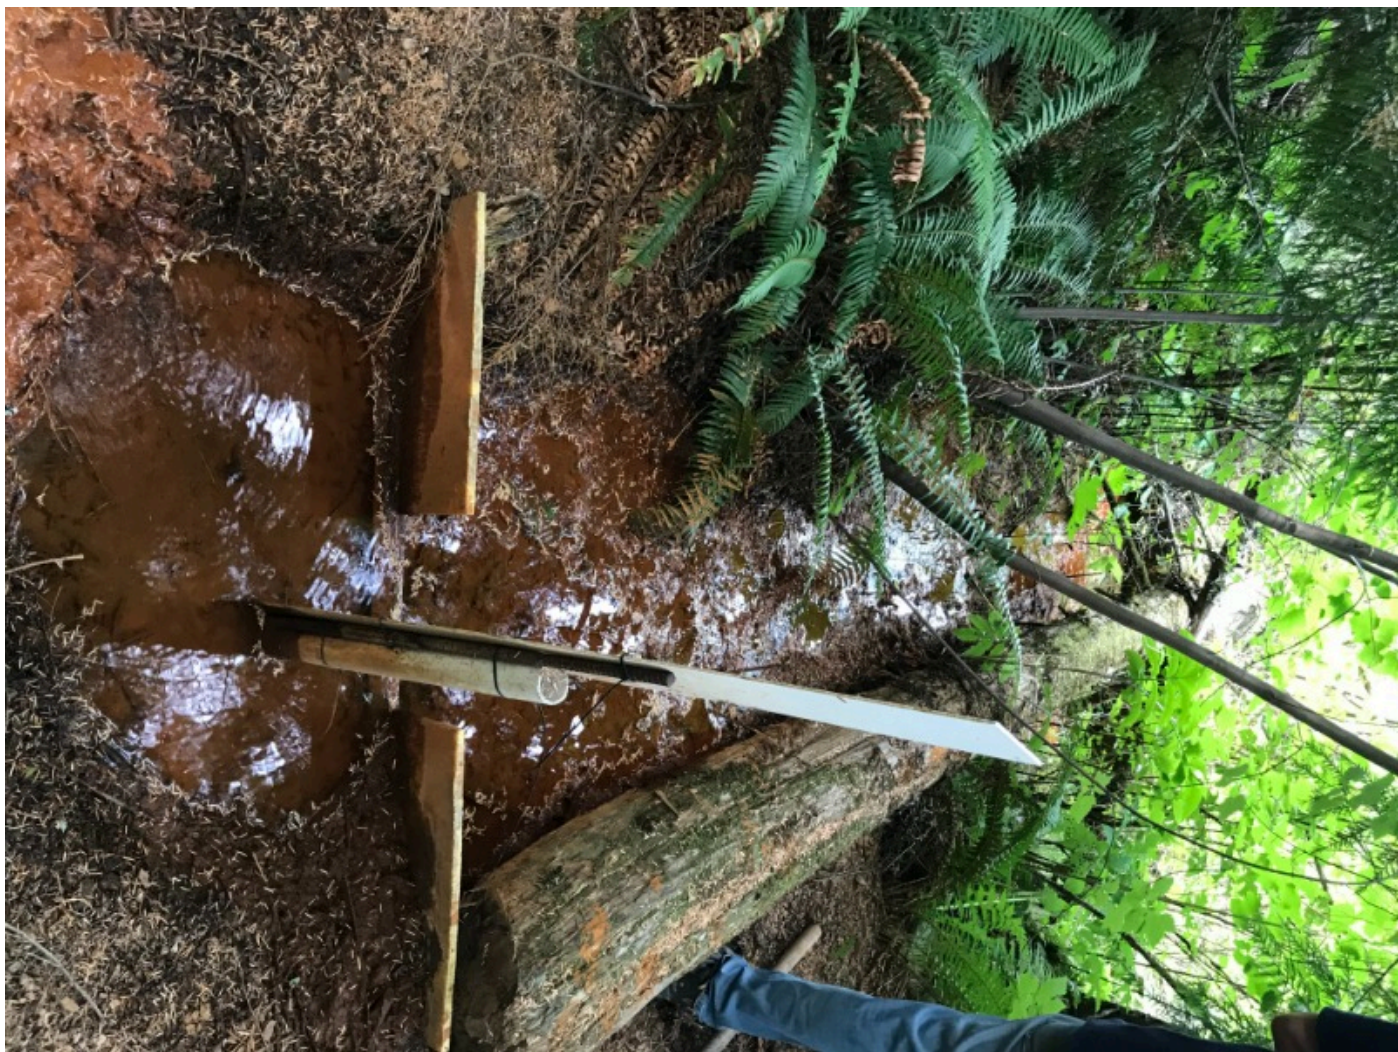
Img : Photo (71).jpg

Img comment: Photo 6 - LLS Seep weir

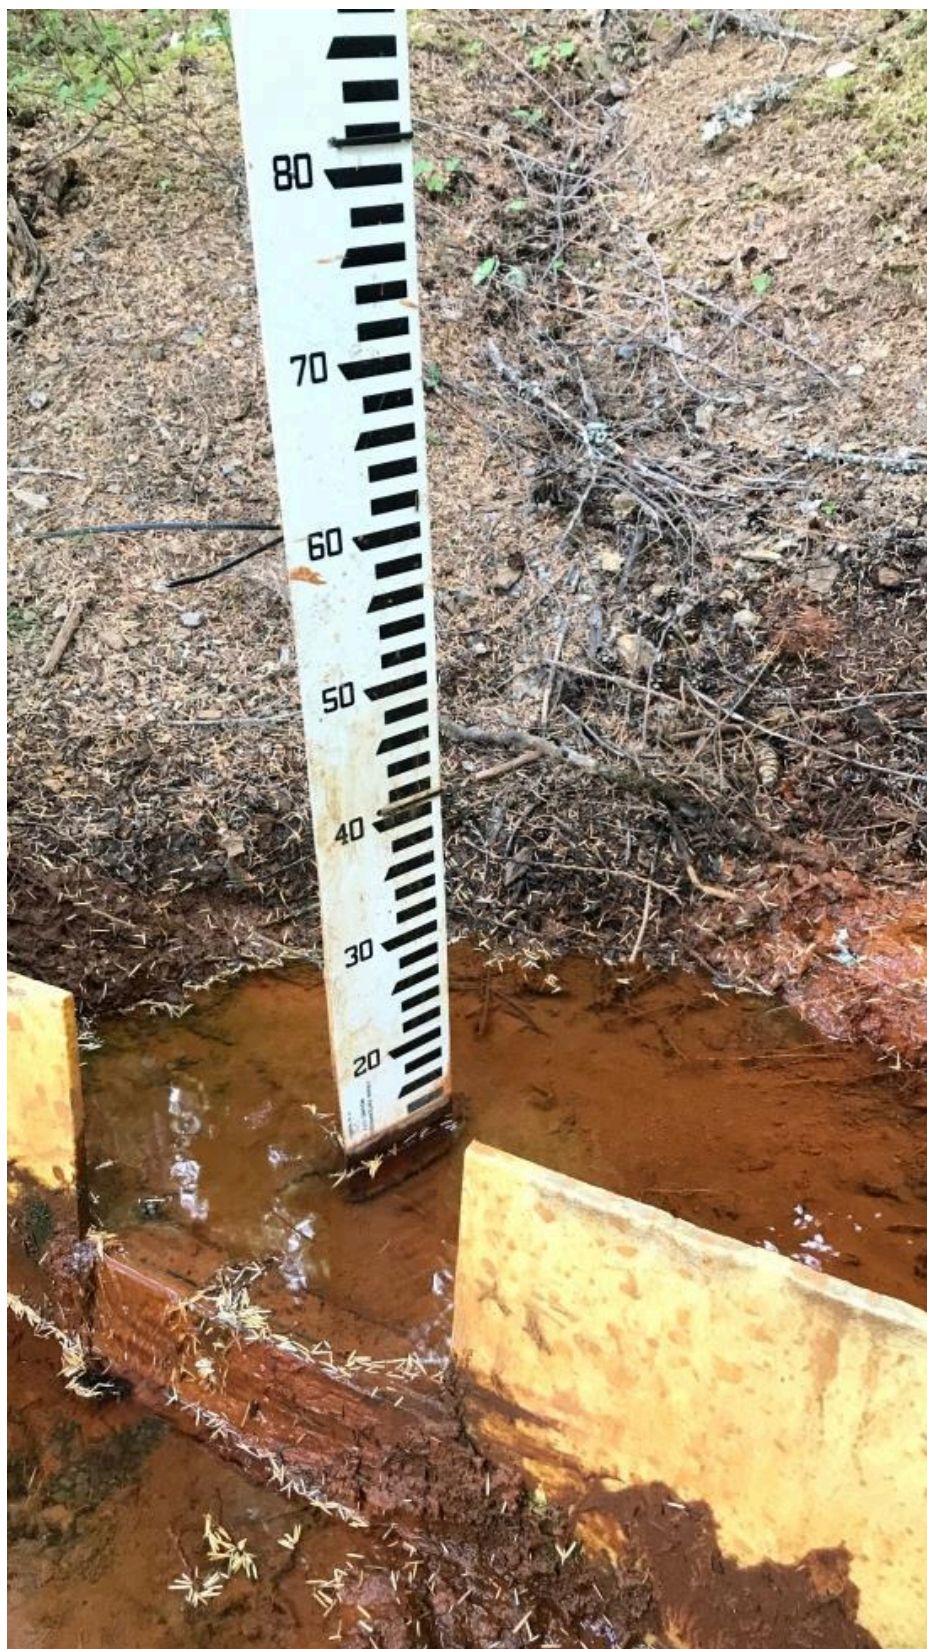
Img : 2021-08-19 Jason Photo (6).jpg
Img comment: Photo 7 - LLS Seep weir
