Appendix V

Report Date: November 03, 2021

Report Number: 178045

Re: Warning Letter, Unauthorized Discharge, Quinsam Coal Corporation, 5800 Argonaut Main, Campbell River, BC, Effluent

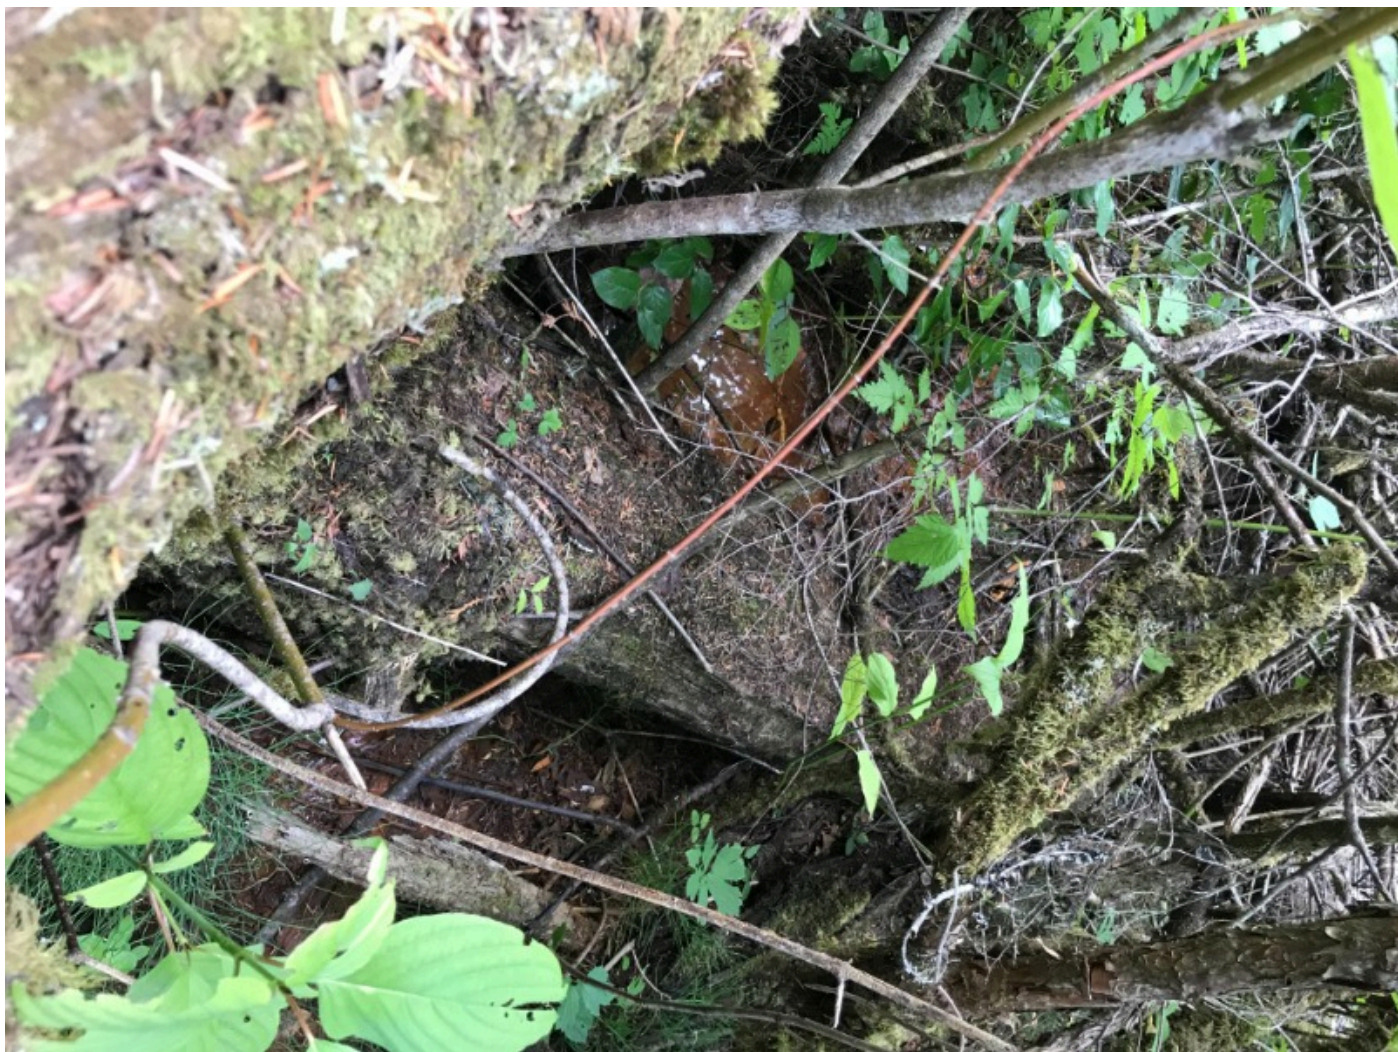
Img : Photo (72).jpg

Img comment: Photo 8 - LLS flow path down gradient of the weir, close to Long lake, covered in vegetation

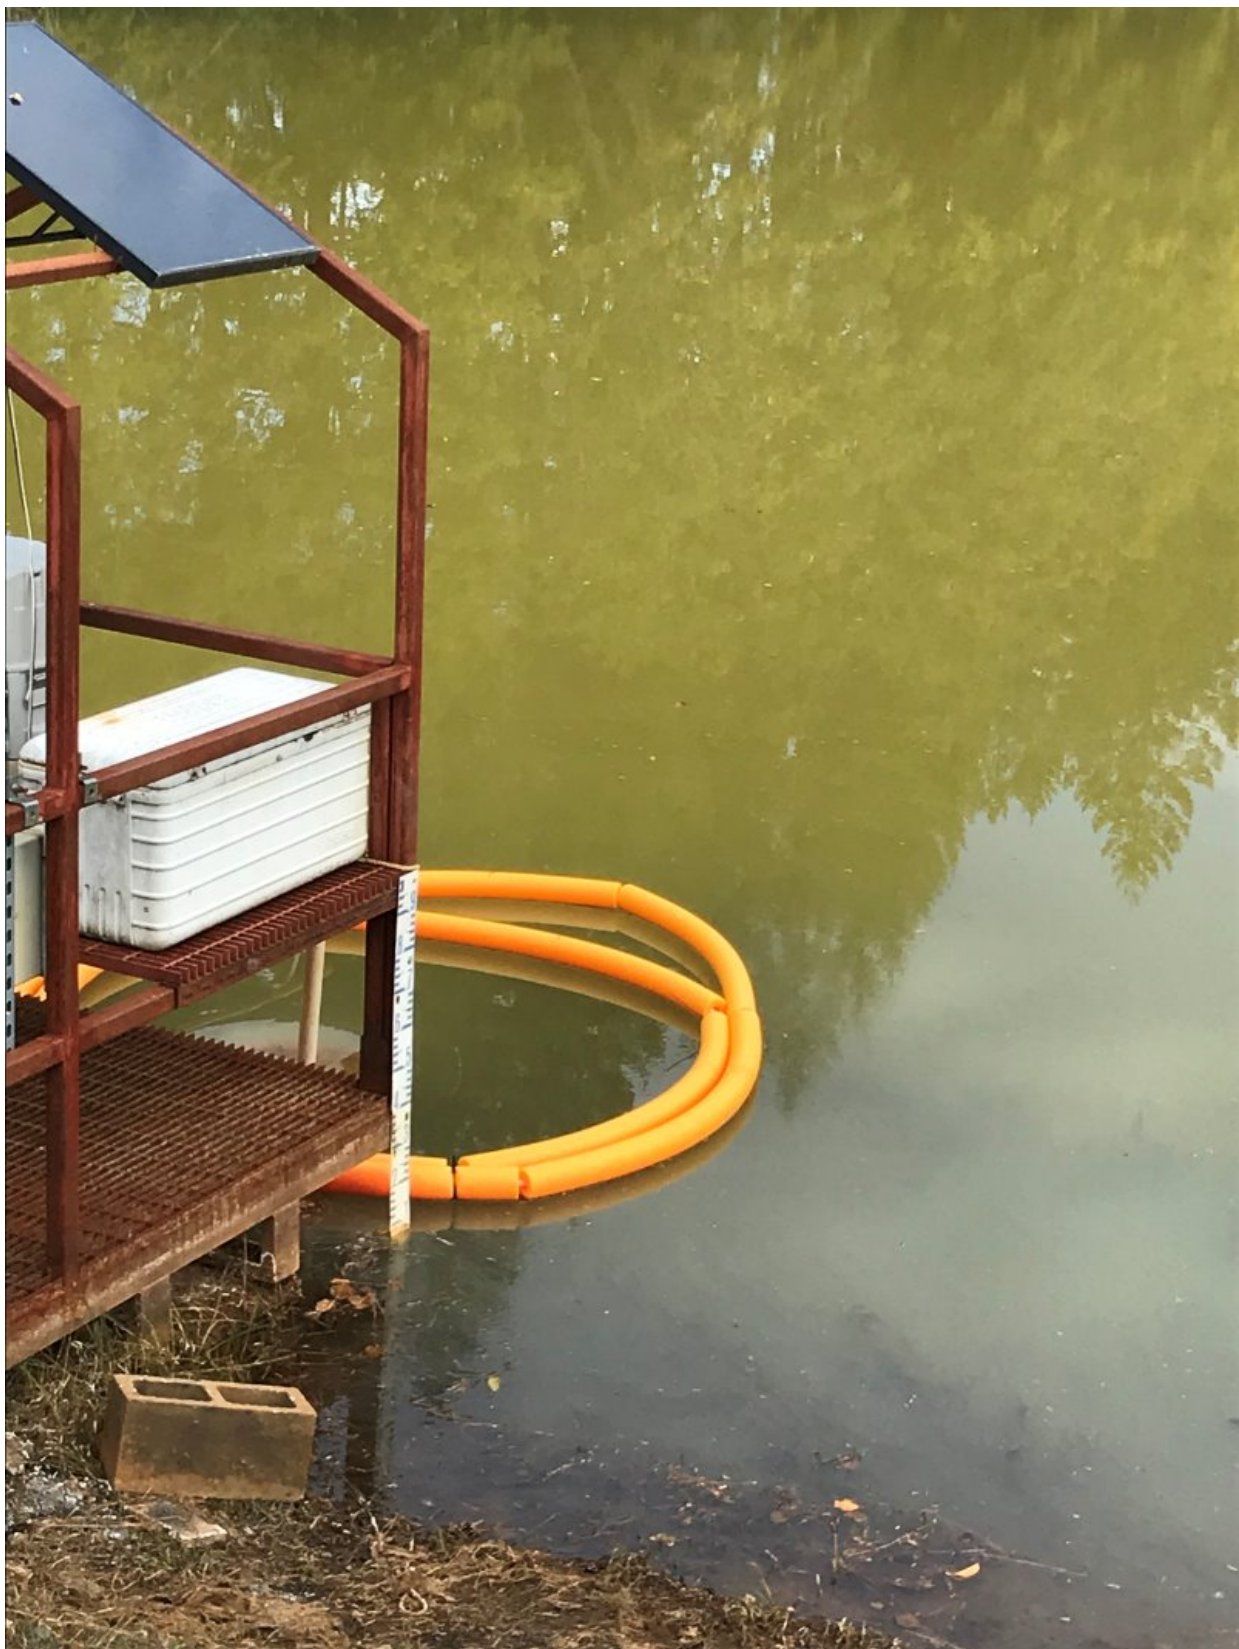
Img : Photo (82).jpg

Img comment: Photo 1 - Settling Pond 4 pond decant with water depth below the 1.0 m mark.

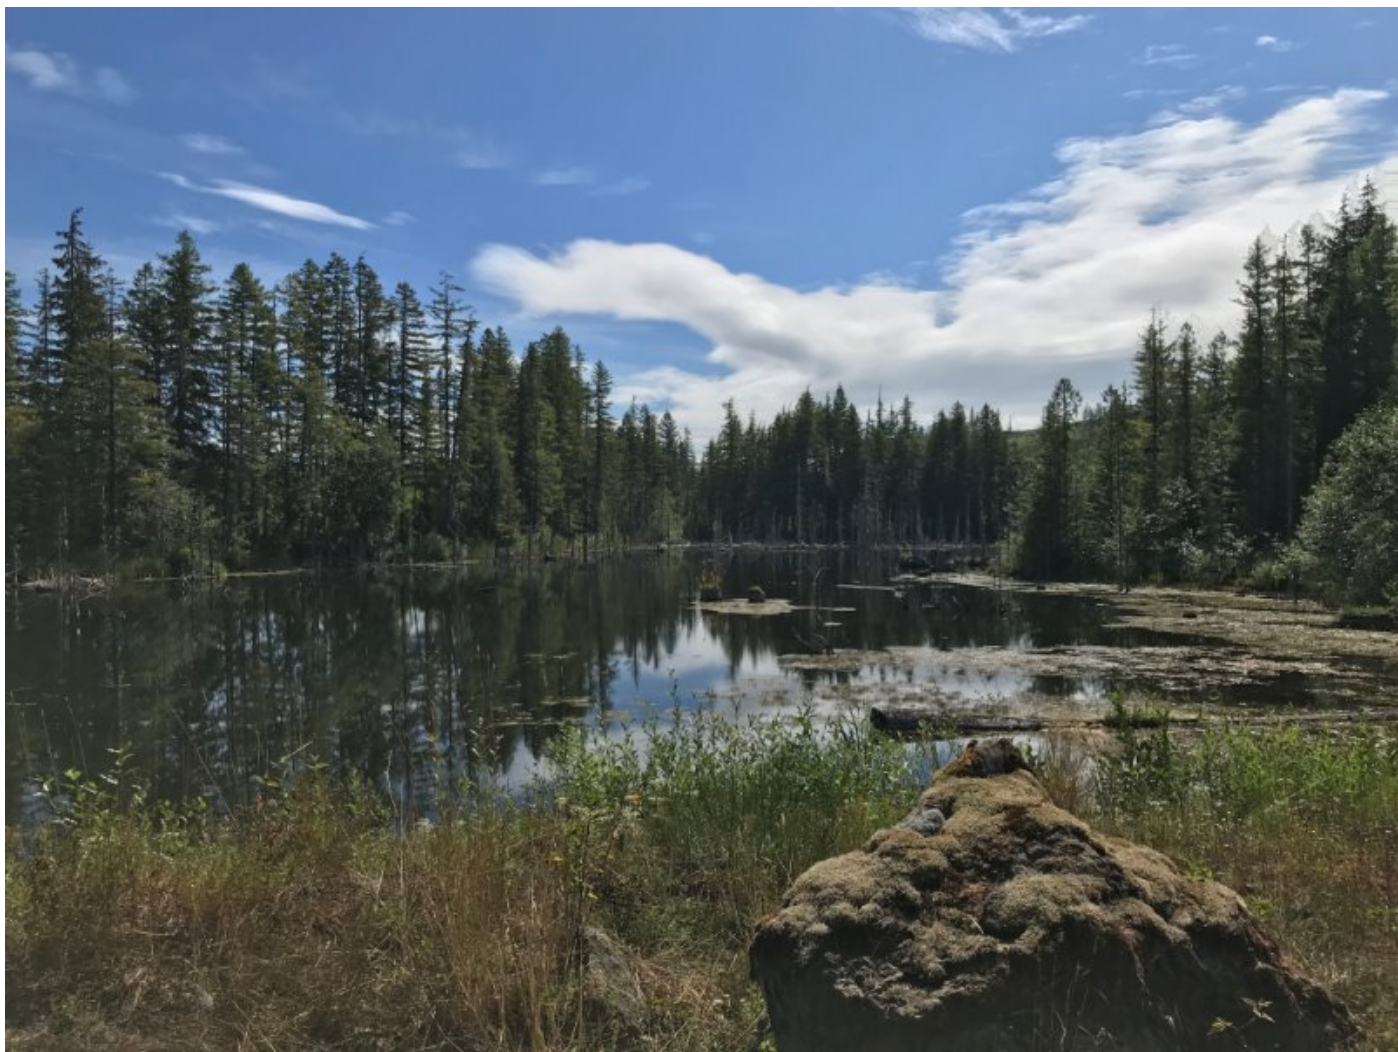
Img : Photo (35).jpg

Img comment: Photo 2 - Settling Pond 1 with some algae growth on the surface.

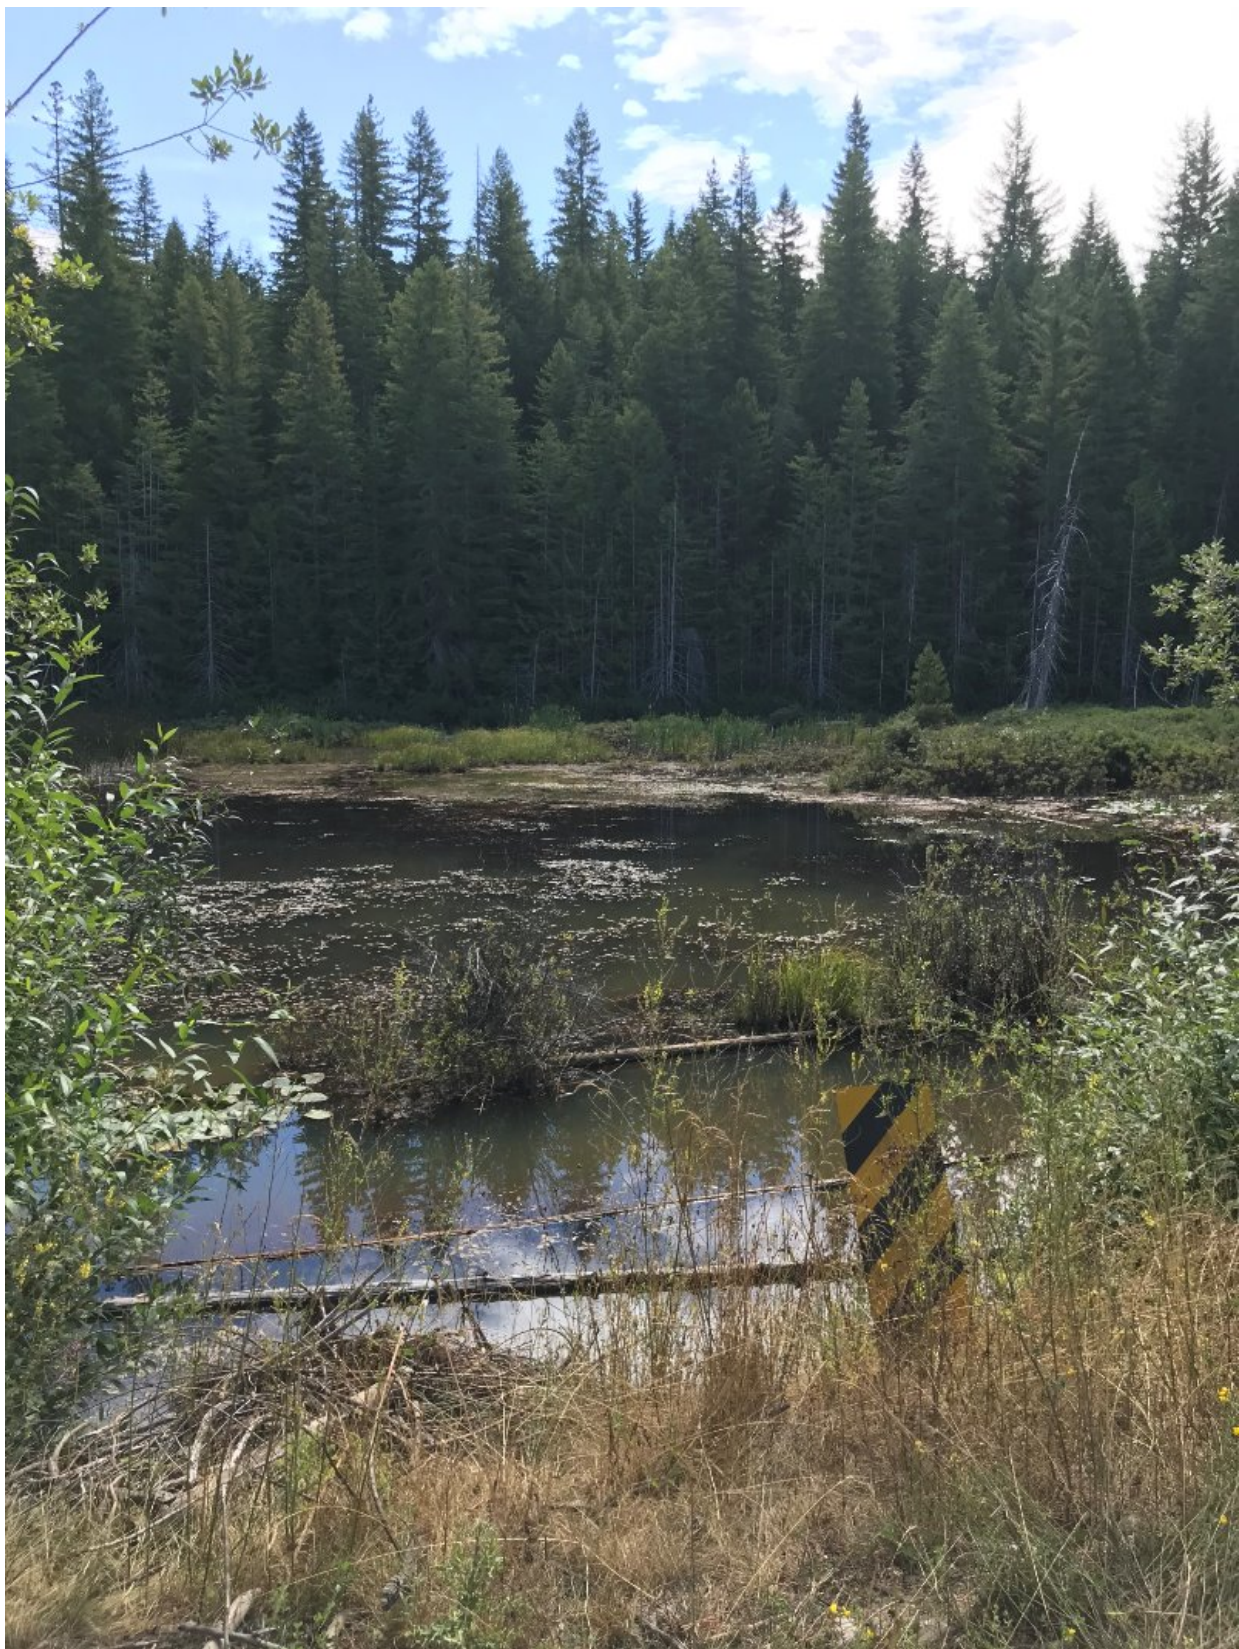
Img : Photo (33).jpg

Img comment: Photo 3 - LLE with some algae growth on the surface

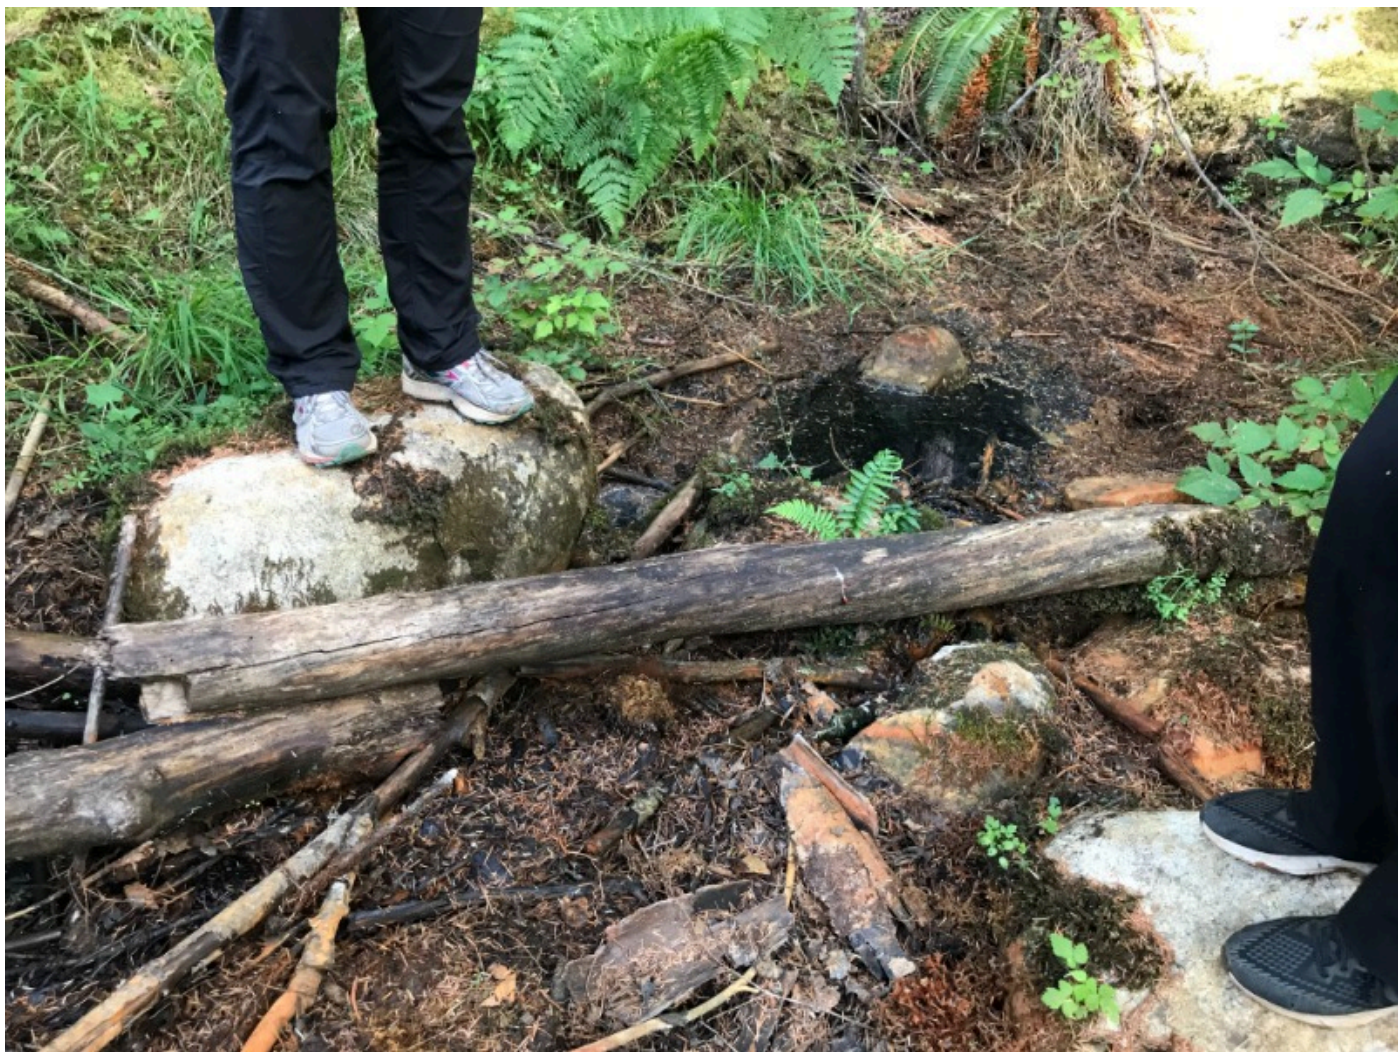
Img : Photo (25).jpg

Img comment: Photo 4 - groundwater seep near groundwater well QU11-09 flow path to Quinsam River - this part of the path was near the head where it was first observed coming out of the ground

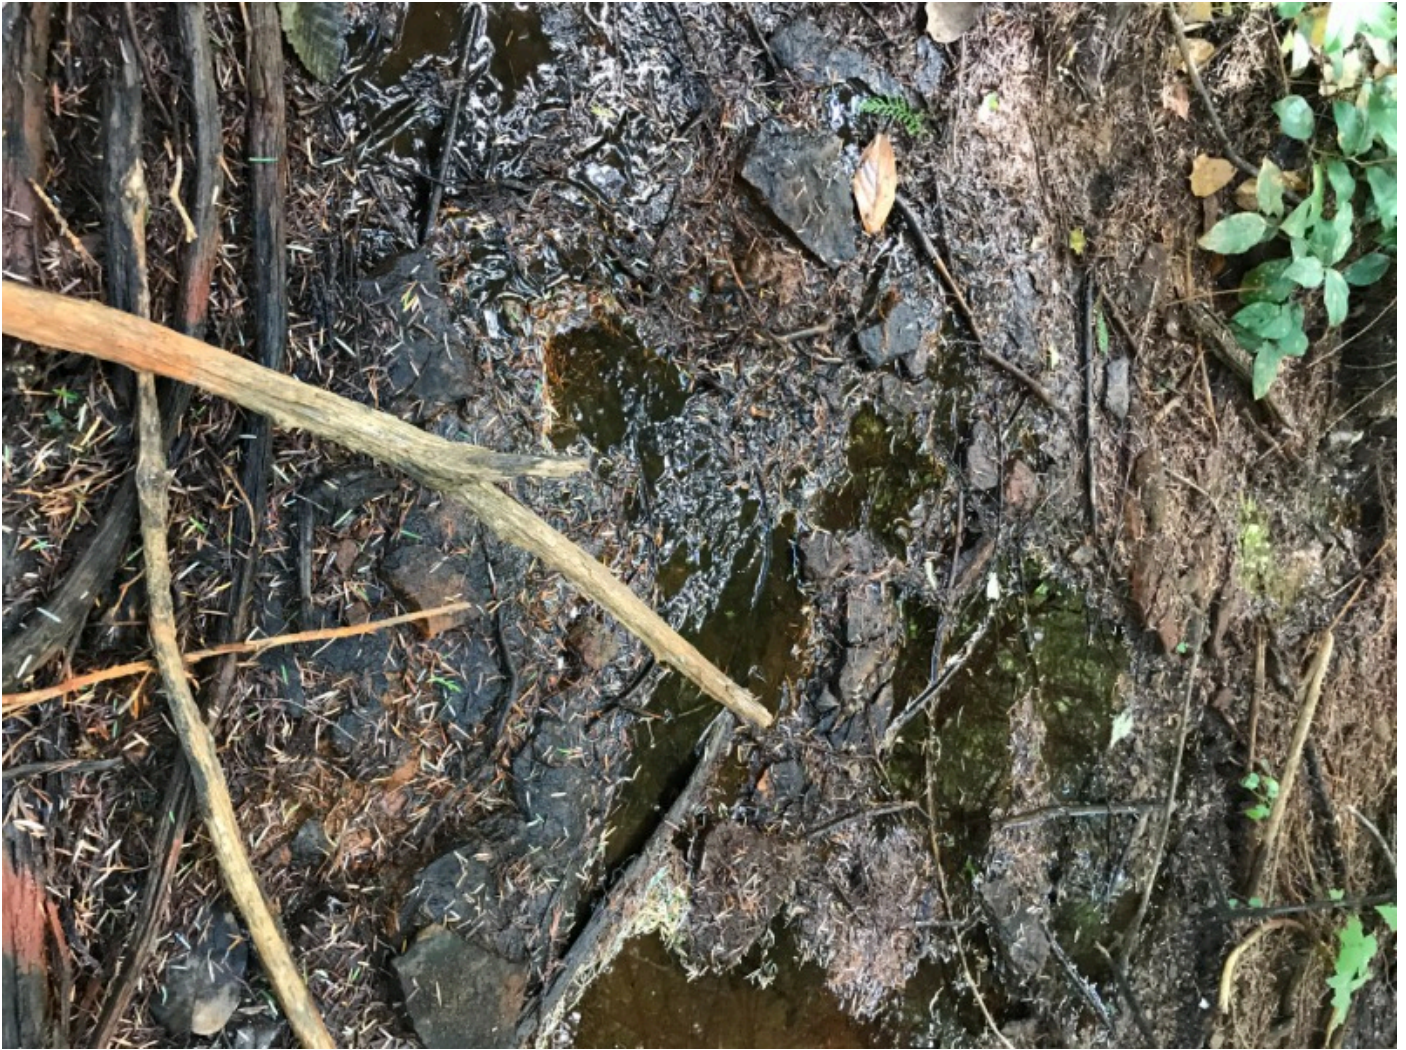
Img : Photo (28).jpg

Img comment: Photo 5 - flow path of groundwater seep near groundwater well QU11-09 - this part of the path was close to the River but puddles did not reach the river

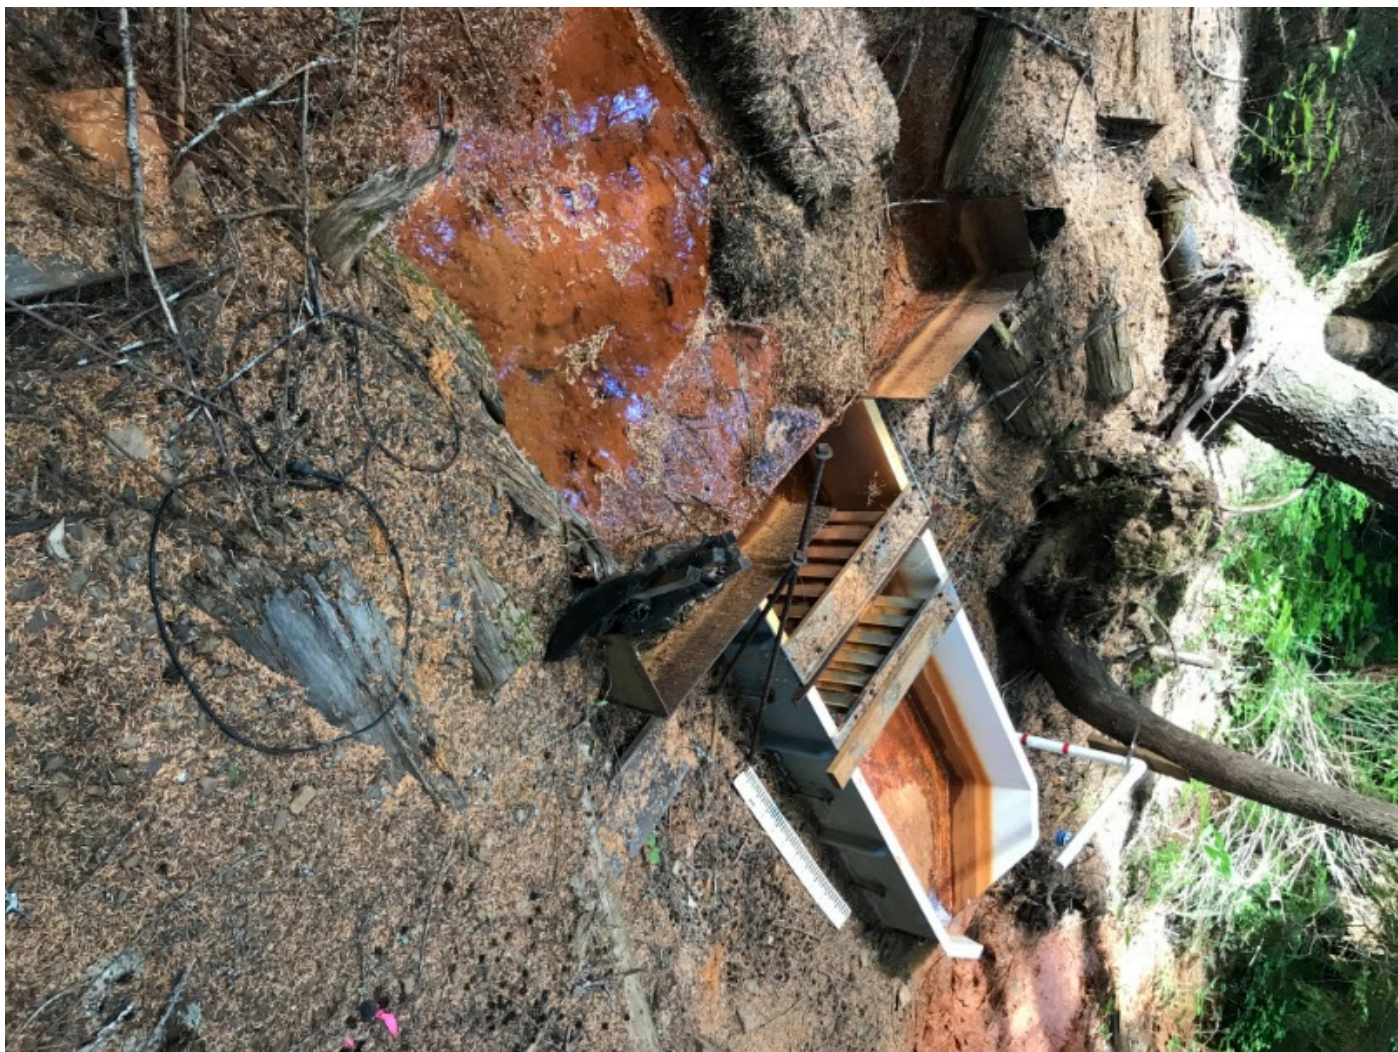
Img : Photo (60).jpg

Img comment: Photo 6 - LLSM Seep flow path taken from up gradient

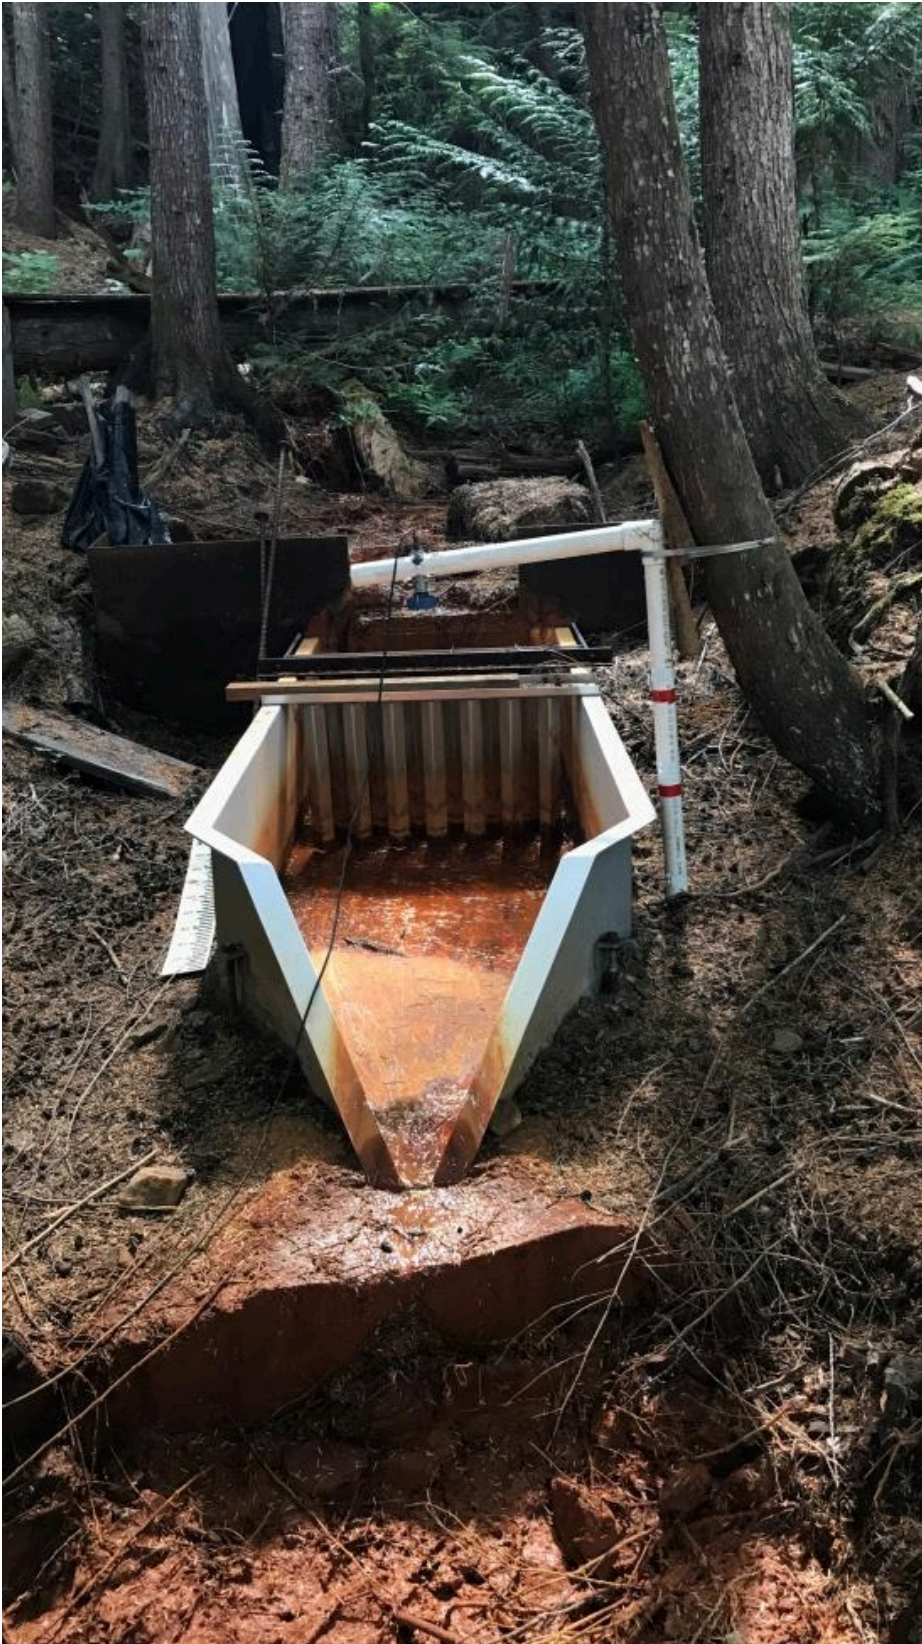
Img : 2021-08-19 Jason Photo (1).jpg

Img comment: Photo 7 - LLSM Seep flow path with mud and the flow appearing to end here

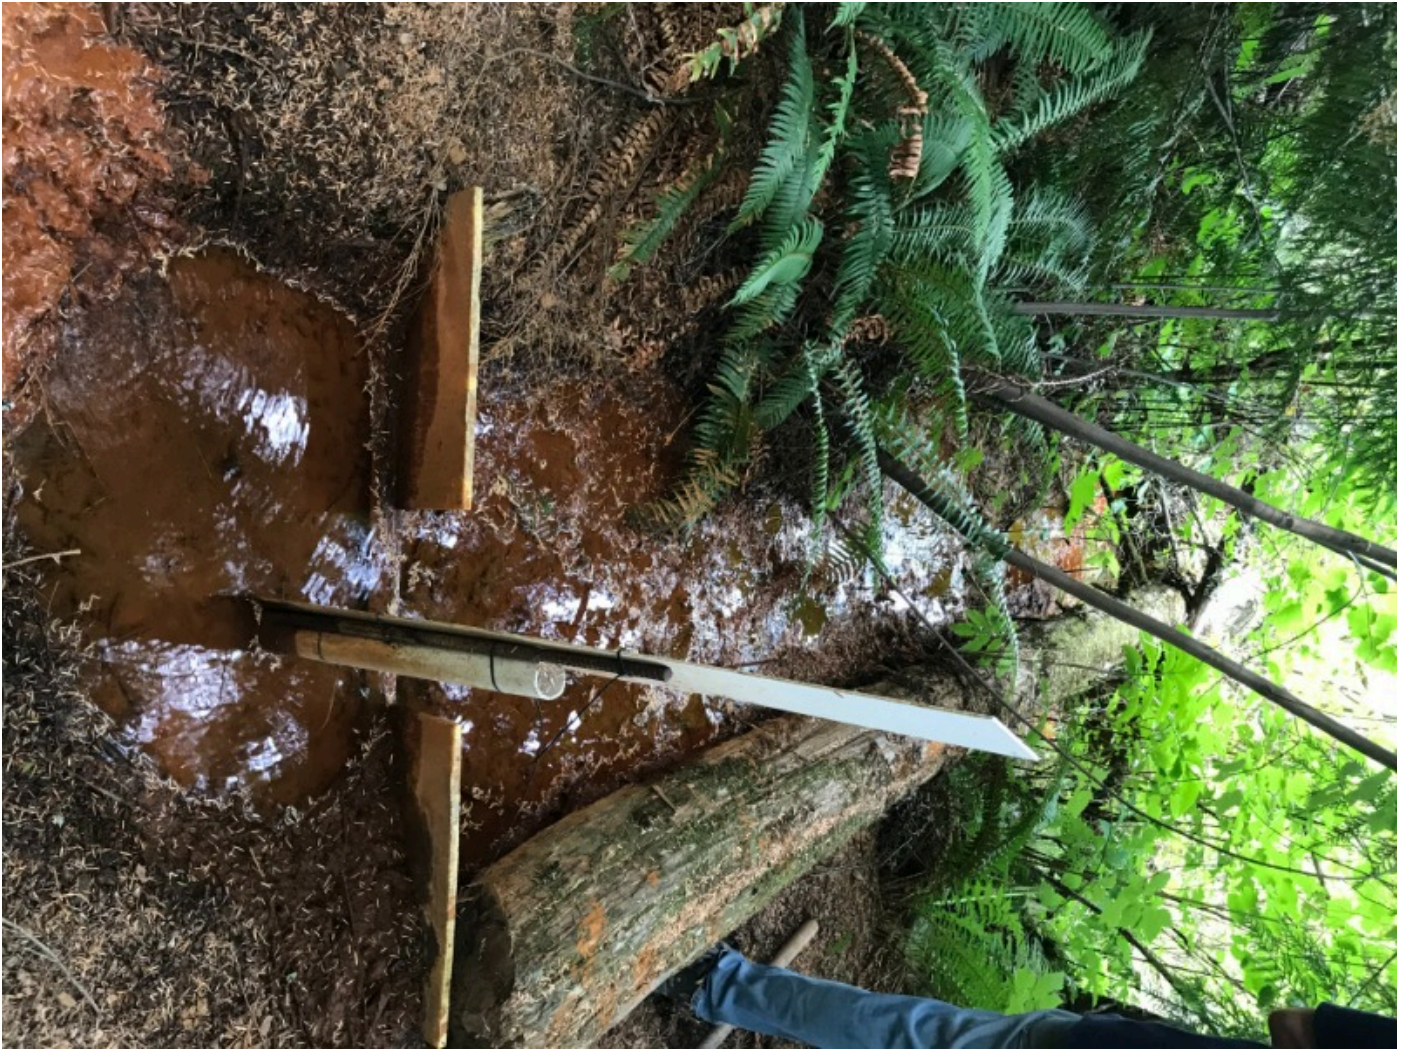
Img : Photo (71).jpg

Img comment: Photo 8 - LLS Seep weir

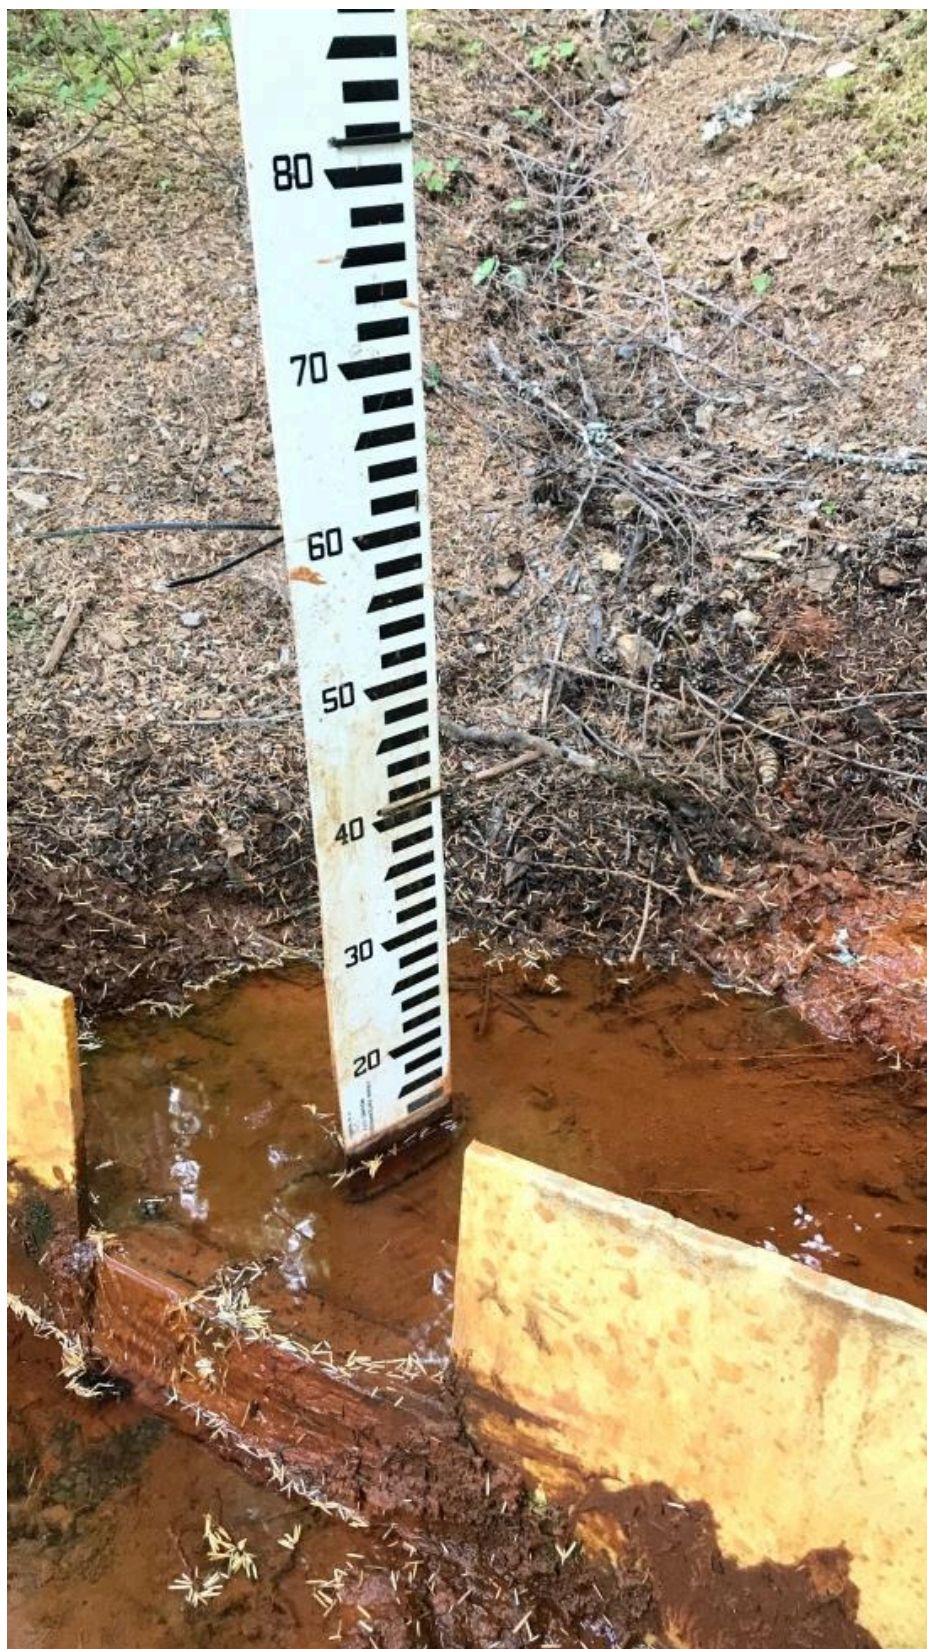
Img : 2021-08-19 Jason Photo (6).jpg
Img comment: Photo 9 - LLS Seep weir

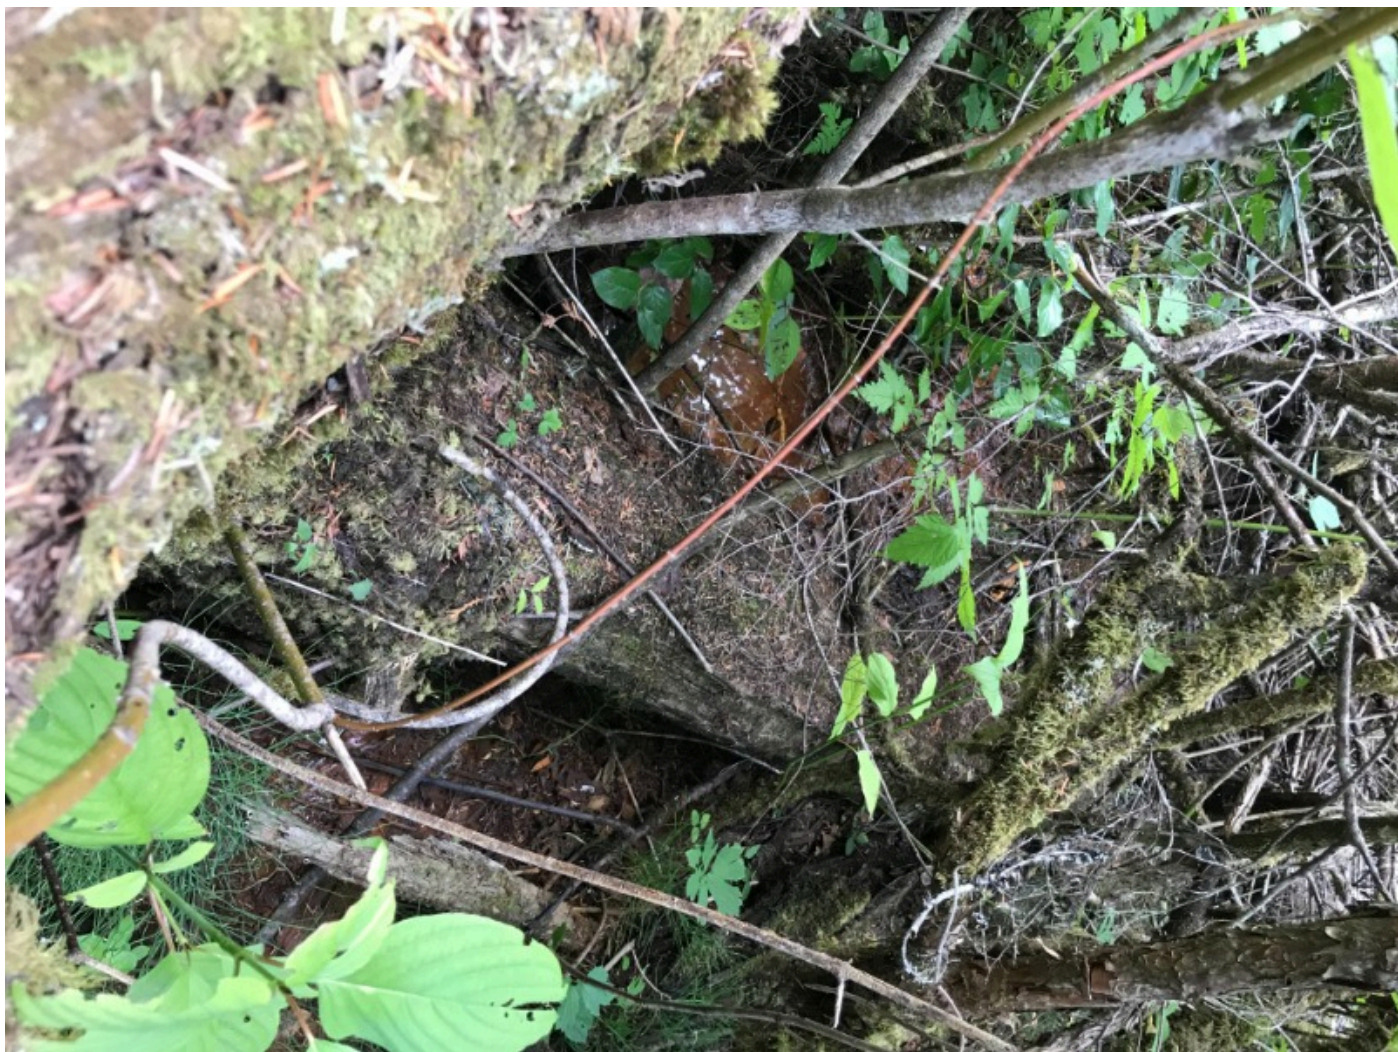
Img : Photo (72).jpg

Img comment: Photo 10 - LLS flow path down gradient of the weir, close to Long lake, covered in vegetation
