PE:7008 Non-Compliance Report EMS ID: E218582 (DGI # 214321)

Subject: Permit non-compliance report for authorization number PE:7008, EMS # E218582, Settling Pond #1 (SPD), issued under Section 14 of the *Environmental Management Act*.

PE:7008 Follow-Up Report Unauthorized Discharge DGIR 204584

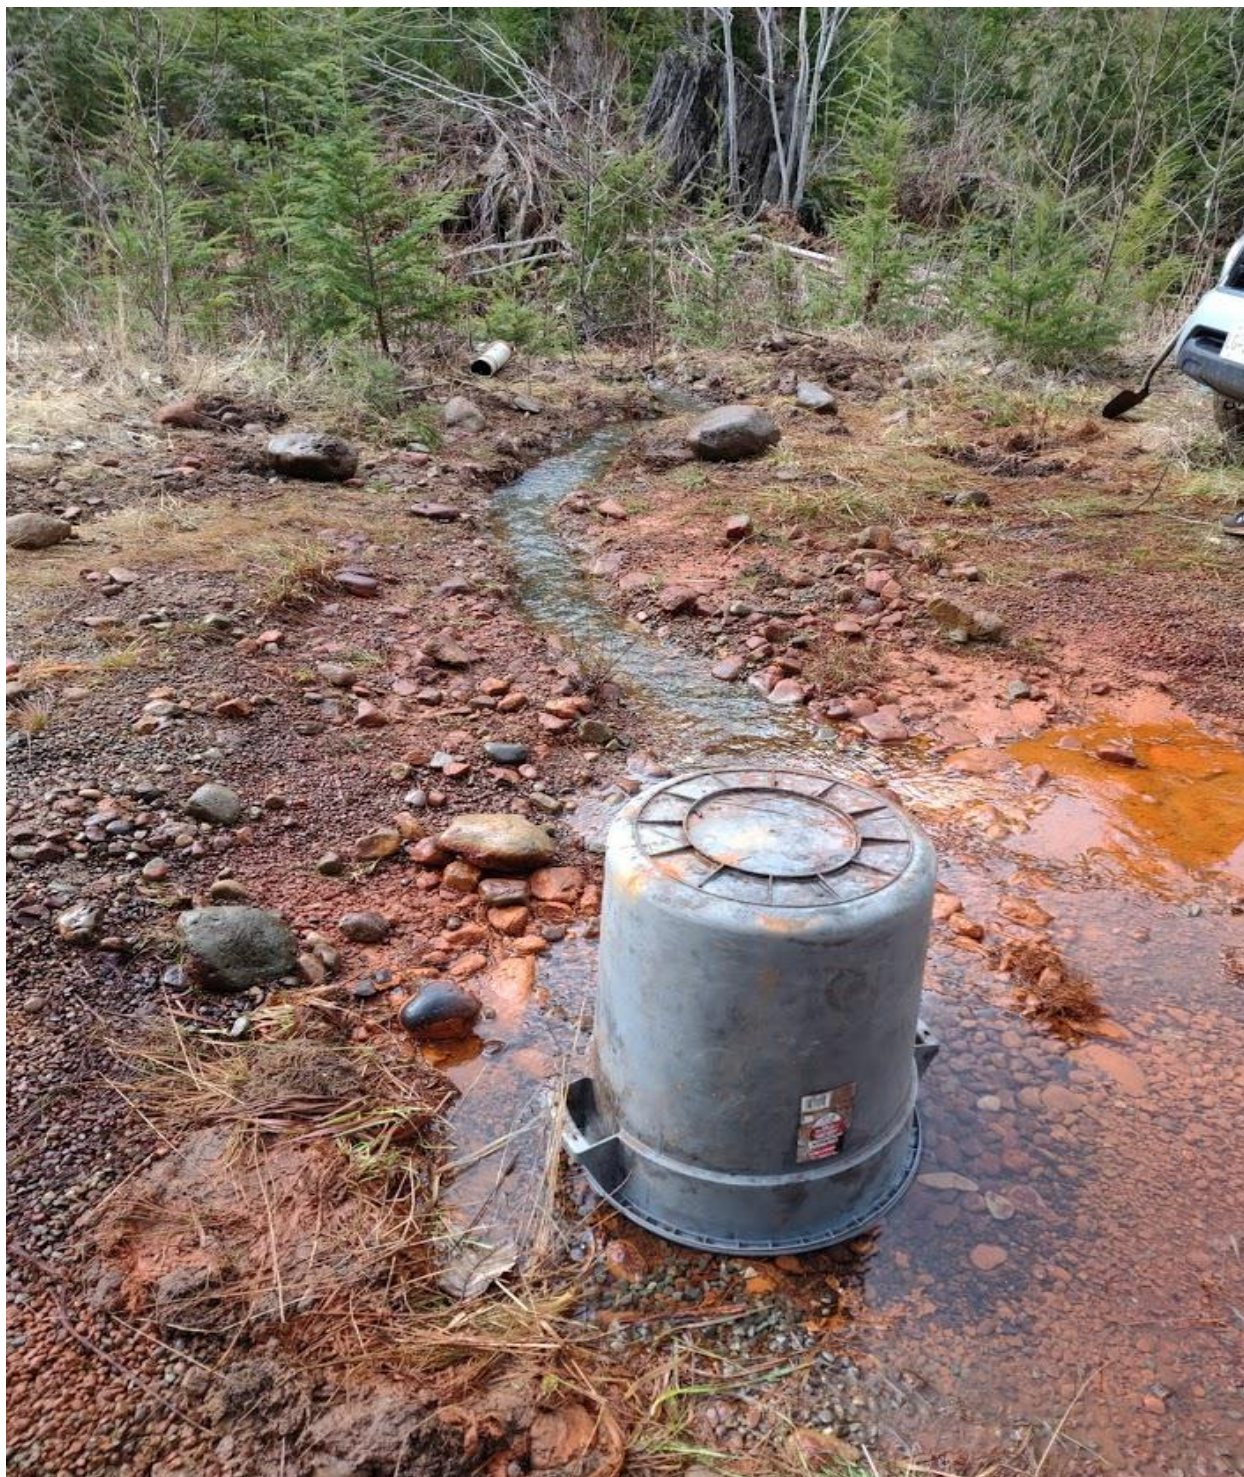
Figure 3: March 18, 2021 discharge contained and directed into a low-lying sump area next to the well away from the river.

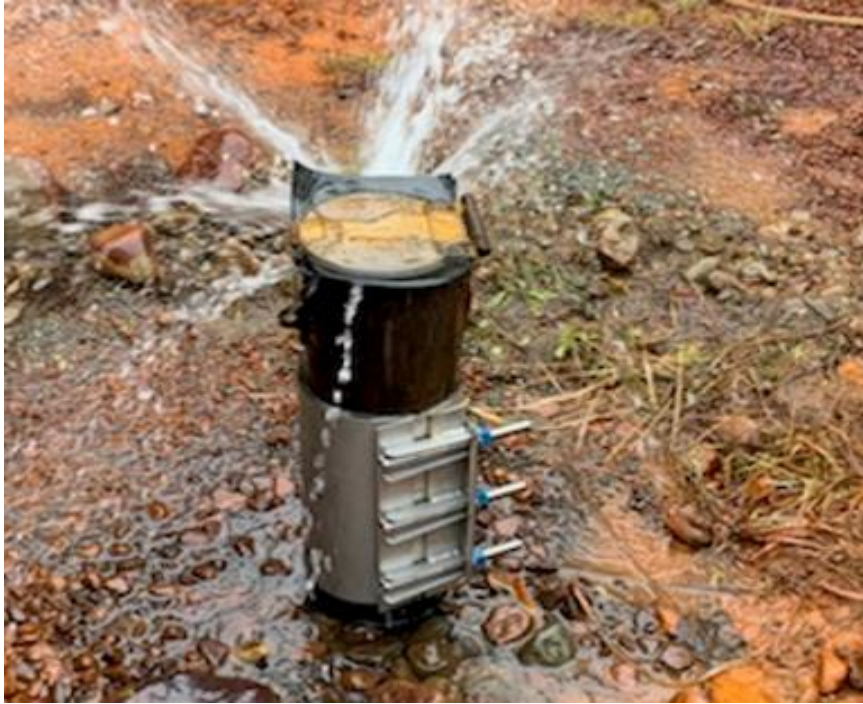
Figure 4: March 19, 2021 well capped and discharge reduced to about 1 L/s. Discharge still directed to the sump area. No surface expression to the river from the well. Well stopped discharging on May 13, 2021 when mine pool was reduced below 226 mASL.

Future action items: The elevation of the mine pool has been reduced to below the elevation of the groundwater well, 226 mASL. The closure plan for the mine will reflect this well being capped

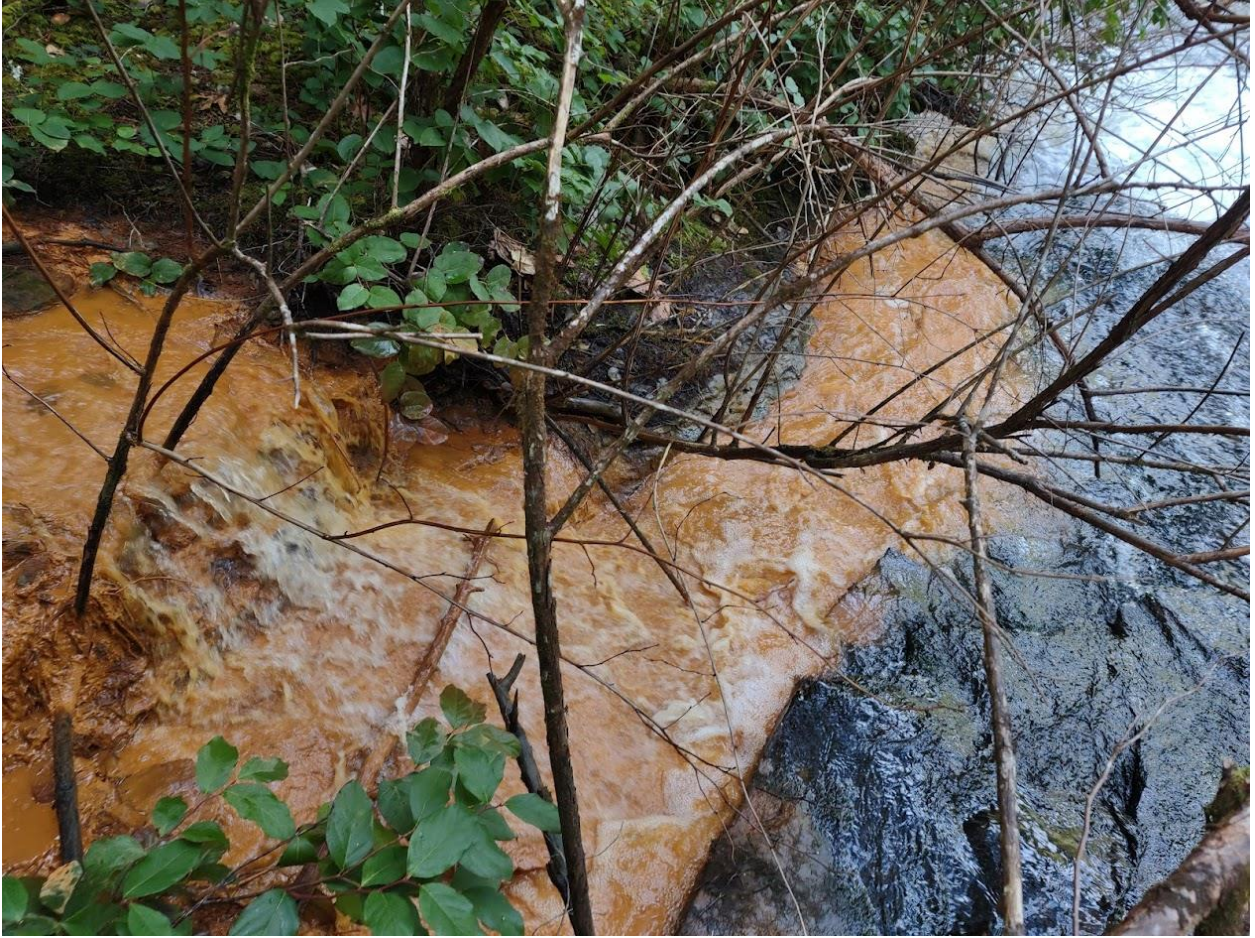
Nature of Non-compliance: Groundwater well (QU11-09) accessing the River Barrier Pillar mine pool, became artesian and discharged to the Quinsam River. The flow path from the well to the

river was 157 m. Iron was deposited and dropped out along the flow path. At the river, iron was deposited on the riverbed for about 5m.

Figure 7: Initial Flow Path into River
