PE:7008 Non-Compliance Report EMS ID: E218582 (DGI # 214321)

Subject: Permit non-compliance report for authorization number PE:7008, EMS # E218582, Settling Pond #1 (SPD), issued under Section 14 of the *Environmental Management Act*.

PE:7008 Follow-Up Report Unauthorized Discharge DGIR 204584

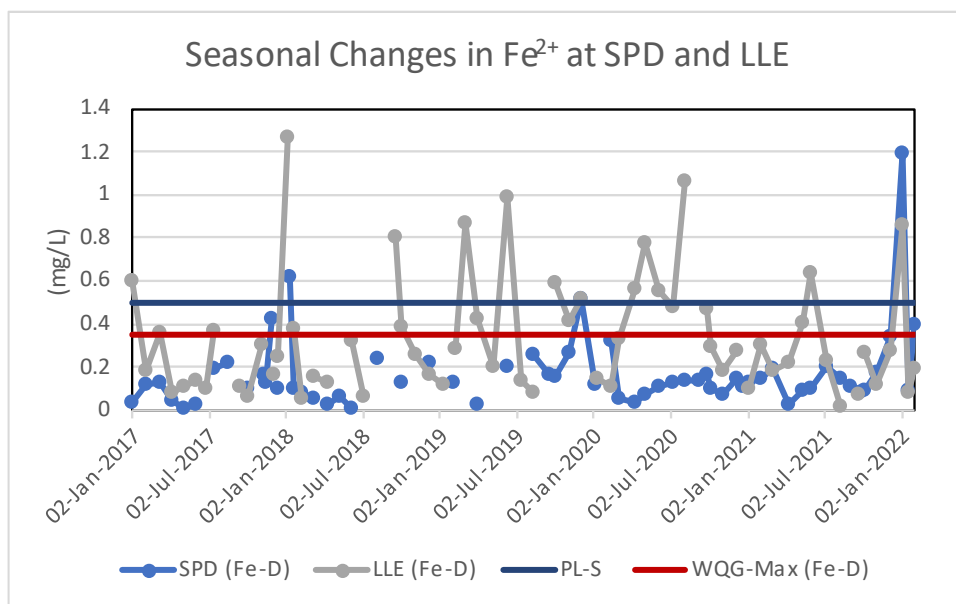
The elevated iron indicates these sites may be experiencing the same type of anoxic conditions where iron changes state and is cycling out of the sediments. Figures 1 and 2 below display the seasonal changes in both Fe^{2+} and Fe^{3+} at both SPD and LLE over time. As observed Fe^{2+} has been elevated in the winter months previously in 2018 and 2020 at SPD and occurs more frequently at LLE due to this area being a natural wetland where iron is attenuated. Mechanisms of natural attenuation of iron by wetland plants and sediment may be classified by plant uptake and adsorption and/or co-precipitation by iron (oxy)hydroxide formed on the root surface of plants.

Figure 1: Season Changes in Fe^{2+} at SPD and LLE

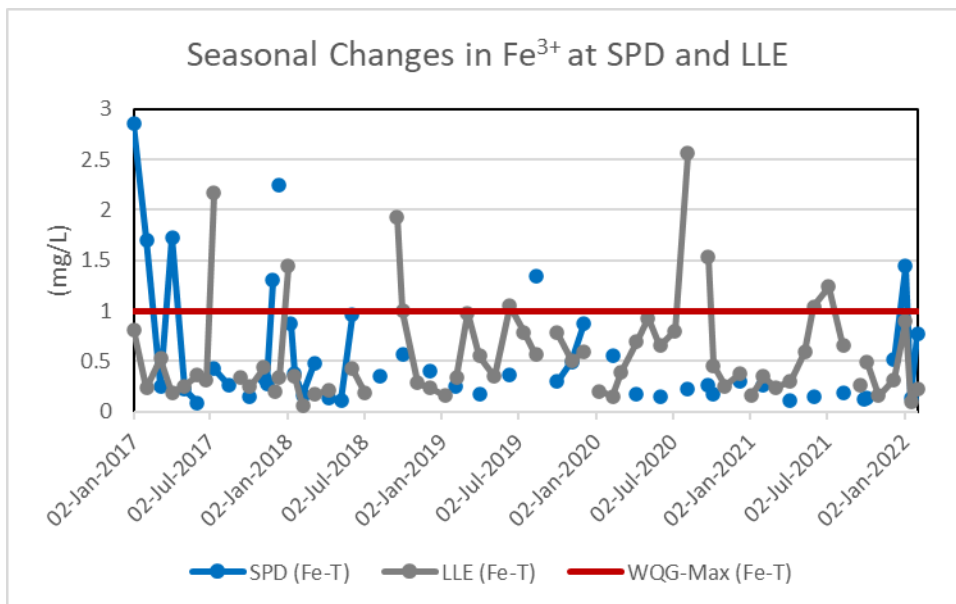
Figure 2: Season Changes in Fe^{3+} at SPD and LLE

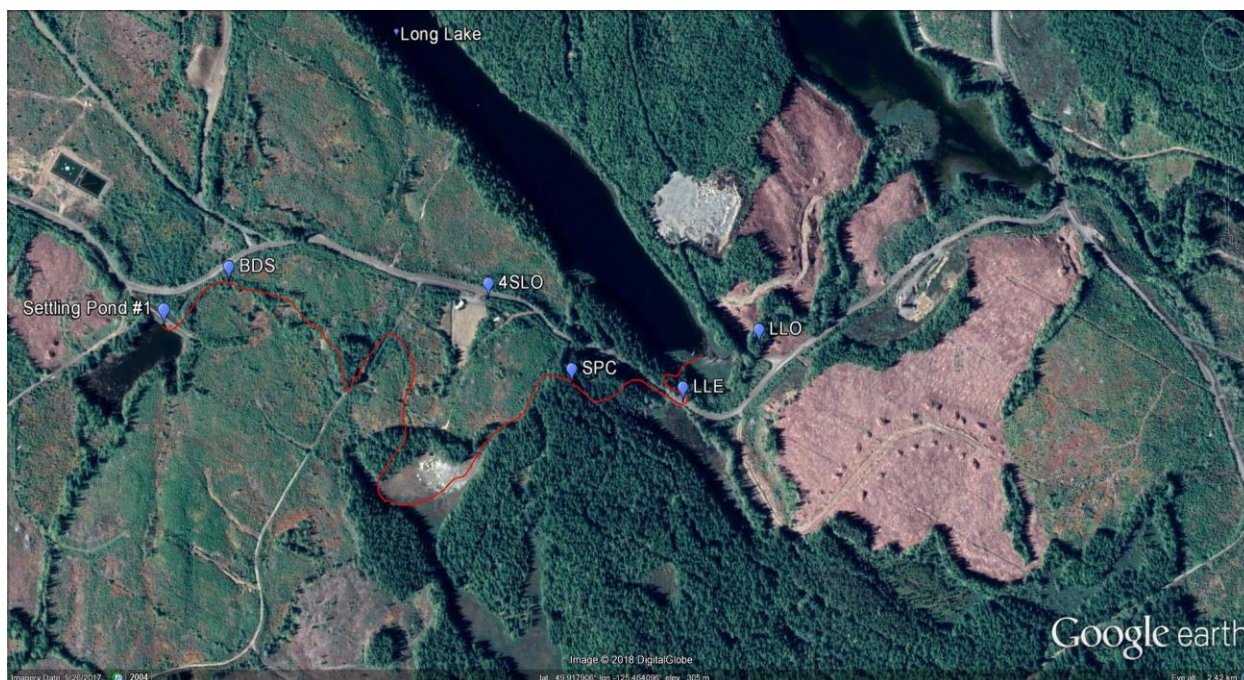
SPD discharge flows through a series of wetlands to the downstream monitoring station LLE prior to entering Long Lake near the outlet (LLO). As displayed in the Google earth image Figure 3 below, the flow path (red line) from SPD to Long Lake is approximately 1.88 km.

Figure 3: South Water Management Flow Path from SPD to LLO

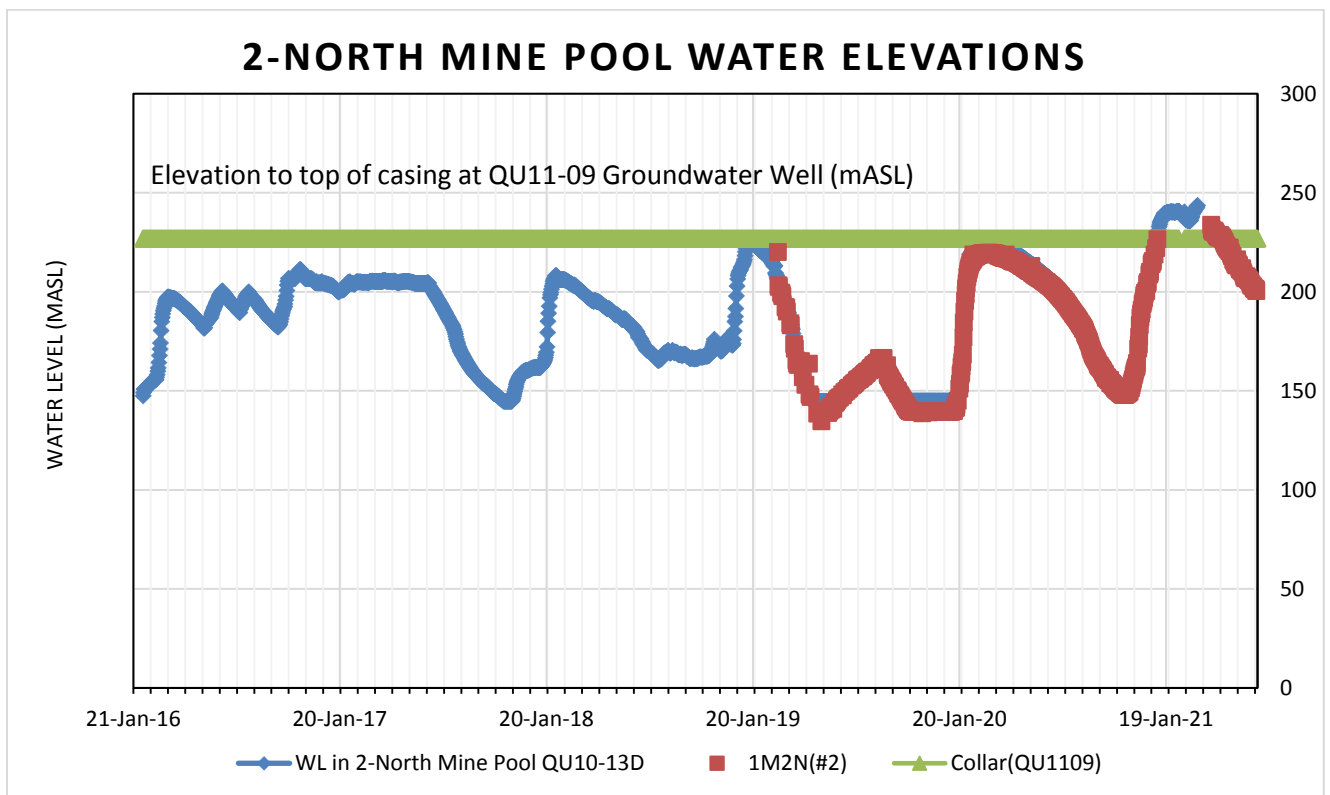
were being managed by the 3M2N pumping system operating at maintaining the mine pool at a higher elevation than normal. The 2-North mine pool water level rose to approximately 244 meters above sea level (mASL) by March 22, 2021. The 3M2N system was installed in order to maintain the mine pool below the known subsidence features in 3-North area, located at 280 mASL, where the mine pool has potential to become a groundwater discharge zone into the Quinsam River and to protect underground infrastructure. The 5M#2 and 1M2N were replaced on March 25 and April 6, 2021, respectively. The groundwater elevation is depicted in the figure below.

Figure 1: 2-North Mine Pool Elevations compared to QU11-09 elevation (mASL)

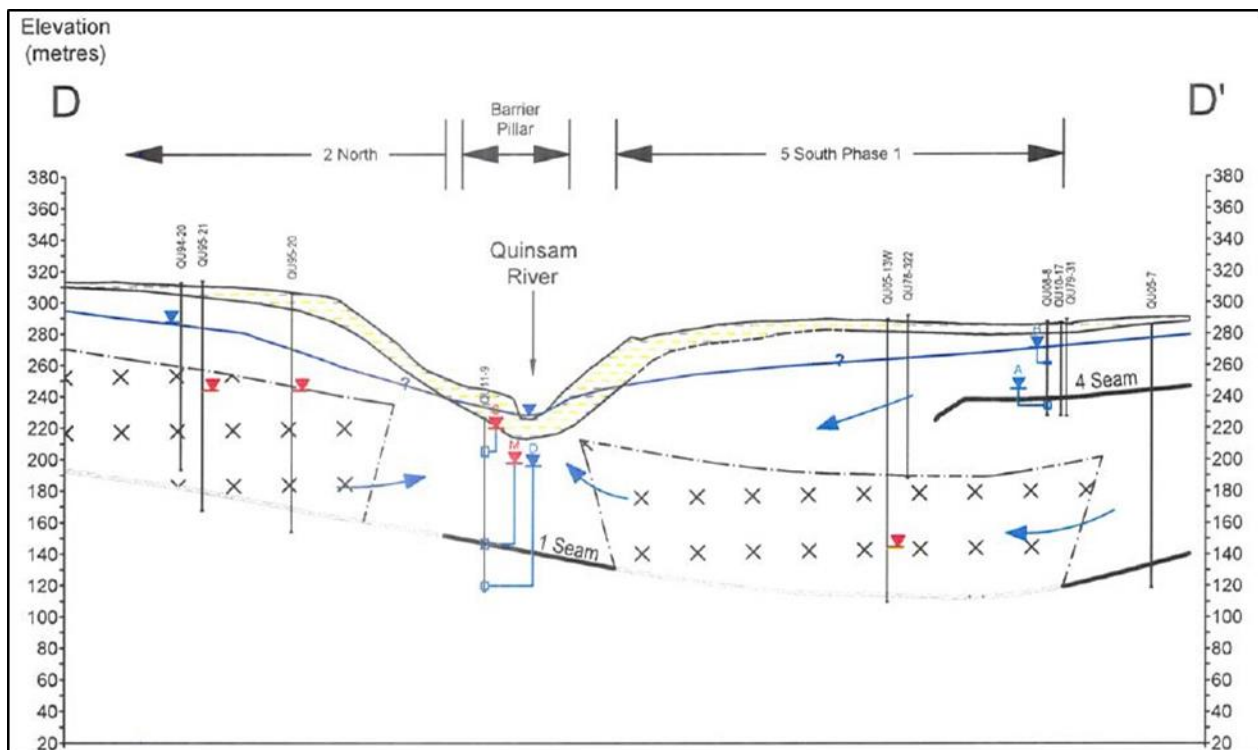
QU11-09 is a nested well that accesses three zones, shallow groundwater, water cover over potentially acid generating (PAG) course coal refuse (CCR) in the No. 1 coal seam and water quality below the 1 seam located in the River Barrier Pillar (RBP) between the 2 North and 5-South Mine. The deep well is not used for sampling. The medium well has a dedicated bladder pump with tubing deployed to assess water quality in the mine pool of the RBP, and the shallow well has hydro lift tubing. Both wells expelled the tubing and pump. The elevation of the well head is 226 masl. The medium well diameter is a 2-inch PVC pipe with a depth 82 m or 142 masl below top of casing (mBTOC). The elevation of the CCR is 153.5 masl. The shallow well diameter is 1.25 inches with a depth of 24.8 mBTOC or 201 masl. Figure 2 below displays the cross section of the 2-North Mine, QU11-09, the Quinsam River and the 5-South Mine.

Figure 2: Cross section of 2-North Mine, River Barrier Pillar (QU11-09) and 5-South Mine

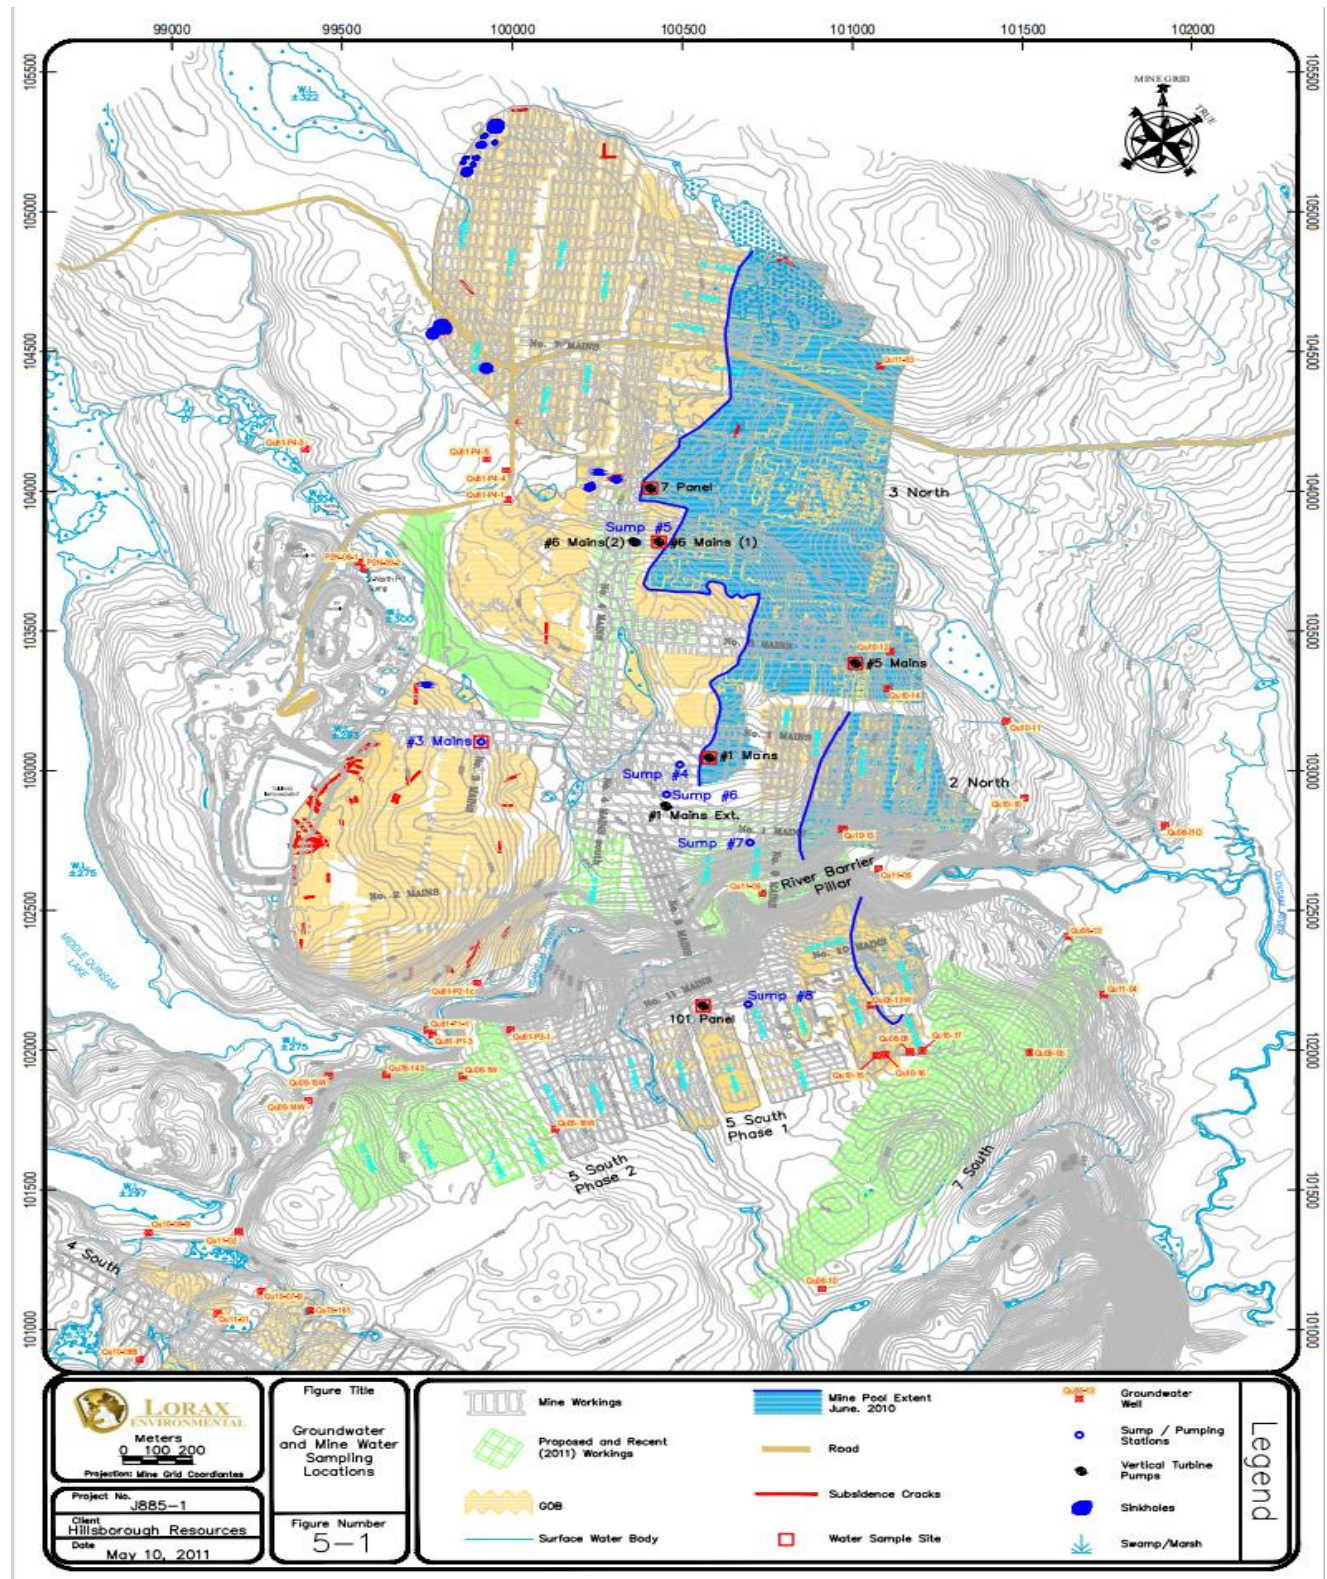
Figure 5: Underground workings and groundwater locations of the Quinsam Mine Site. QU11-09 in the River Barrier Pillar is the location of the artisan well.

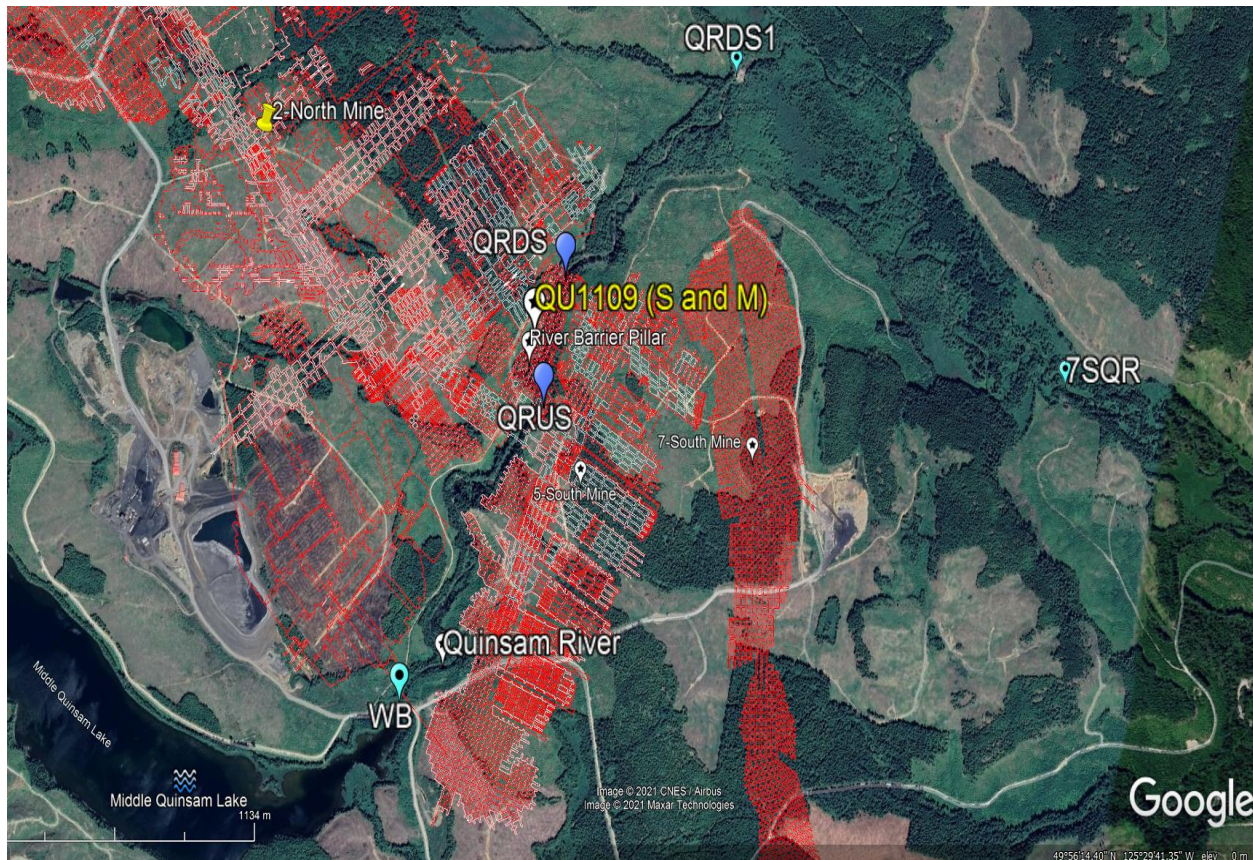
Figure 8: Quinsam River Monitoring Locations and Underground Workings. Spill occurred at QU1109 and discharged into the Quinsam River. Monitoring occurred upstream and downstream on the river at sites WB, QRUS, QRDS, QRDS1 and 7SQR. Seepage continued from shallow groundwater for several months.
